SKF Technical Bulletin

VKJA 3001- Importance of the correct boot tightening

AUDI A4, A6, SKODA Superb, VW Passat

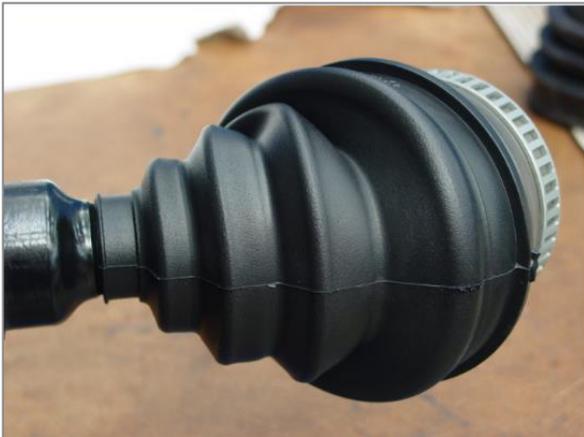
If the small diameter of the boot is tightened too close to the spline of the shaft, the boot coils may tear. If it's tightened too far (Picture 1), the boot will stretch excessively and will cause cracks (Picture 2).

Pic. 1 - Incorrect boot tightening

Before tightening the small boot clamps, ensure the boot is positioned correctly by moving the joint to its extreme angulation. The boot should not look too stretched on one side, and not too compressed on the other side.

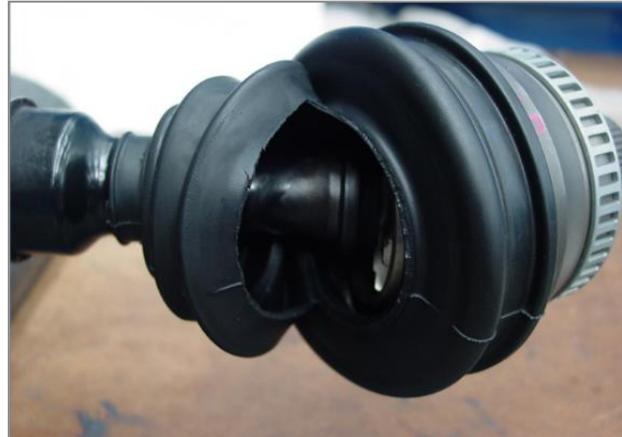
Pic. 2 - Boot cracks due to incorrect tightening

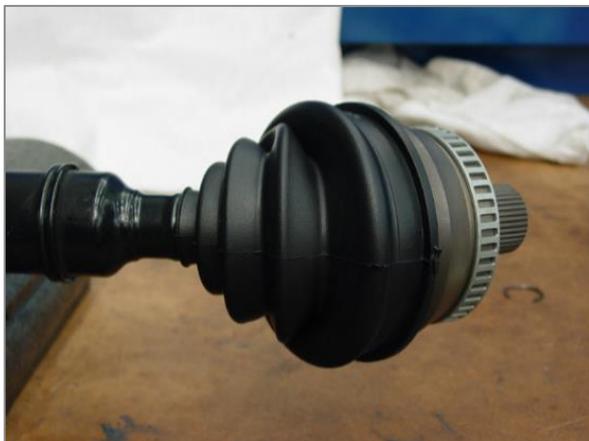
Pic. 3 - Correct position for boot tightening

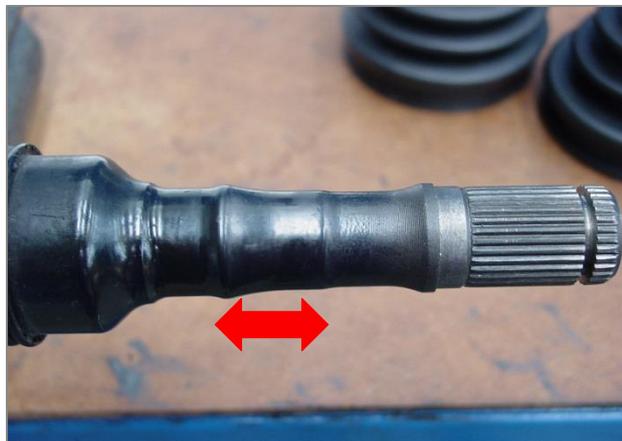
Pic. 4 - Slots for correct boot fitting
