SKF Technical Bulletin

VKJP 3017 - Importance of the correct boot tightening

AUDI A4, VW Passat, Skoda, Superb

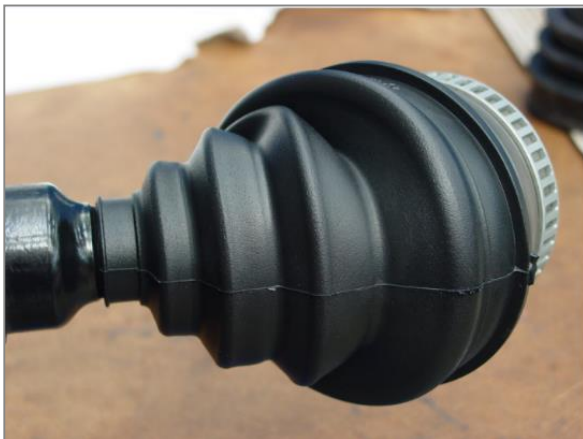
If the small diameter of the boot is tightened too close to the spline of the shaft, the boot coils may tear. If it's tightened too far (Picture 1), the boot will stretch excessively and will cause cracks (Picture 2).

Pic. 1 - Incorrect boot tightening

Before tightening the small boot clamps, ensure the boot is positioned correctly by moving the joint to its extreme angulation. The boot should not look too stretched on one side, and not too compressed on the other side.

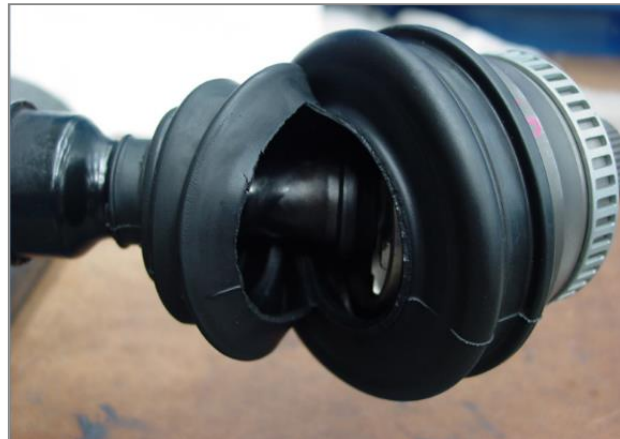
Pic. 2 - Boot cracks due to incorrect tightening

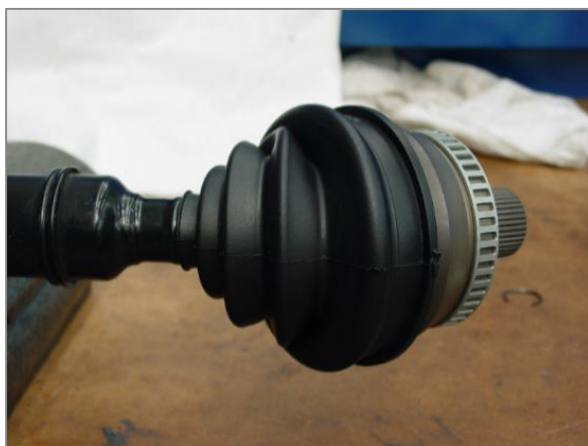
Pic. 3 - Correct position for boot tightening

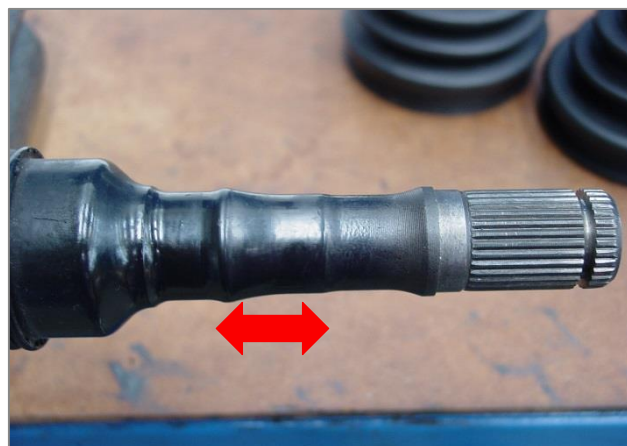
Pic. 4 - Slots for correct boot fitting
