VKM 31013

Technical Bulletin - February 2009

AUDI, SKODA, VW

Technical information - VKM 31013 Fitting Recommendations

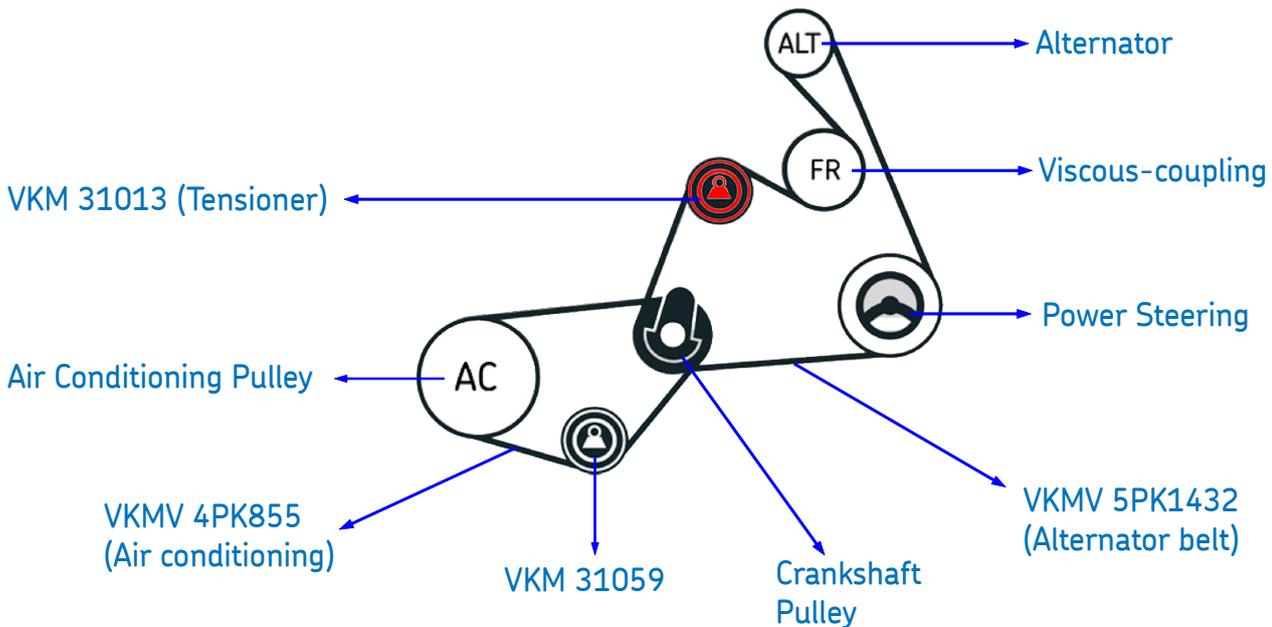
Risks: An incorrect belt length (i.e. shorter or longer), leads to the incorrect tension of the auxiliary system. This can cause a number of problems for your customer – from a noisy drive belt to the possibility of a premature failure of the drive belt completely, which in itself can cause engine failure if the auxiliary drive belt was to enter the timing drive system!

As can be seen by the diagram above, all of the auxiliary systems are driven by multi-ribbed belts - SKF strongly recommend the use of the [exact OE length belt](#) when carrying out a service of the auxiliary drive belt system.

The OE belt length is a key feature when servicing the auxiliary drive system. This ensures the belt is correct to the exact millimetre, which ensures a good repair, with trouble free performance!

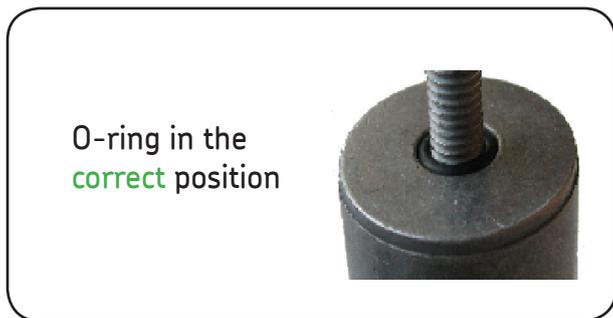
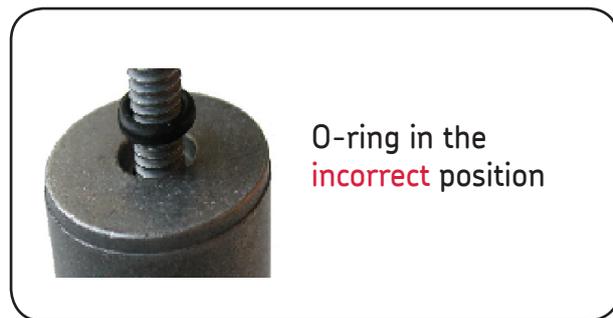
- Before fitting the VKM 31013 tensioner - it is recommended that you clean the bolt location hole on the alternator bracket. If not, the bolt may not be tightened to the correct torque.
- When fitting the tensioner onto the alternator bracket, check the position of the oring located on the bolt, has not moved (see diagrams A and B below). If the o-ring is not correctly located, the bolt may not be tightened properly and the seal will not be in the right position.

Turn the 19mm spanner anticlockwise in order to put the VKM 31013 tensioner in a low tension position. Then, mount the belt onto the plastic idler.

When the belt is correctly located onto the idler - slowly release the 19mm spanner in order to set the correct system tension.

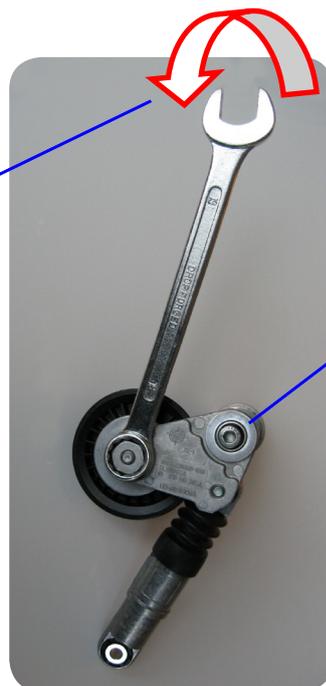
The tightening torque on the bolt bracket is 25 Nm.

This step should be handled with extreme caution, as very high tension is applied to the system at this point. If the spanner slips, it may cause serious injury to the installer!

The correct tension of the VKM 31013 tensioner is set up by the using the exact OE belt
