MANN-FILTER

Product Information

No 141
31/03/2022

Leakage after the change of the oil filter – what's the cause?

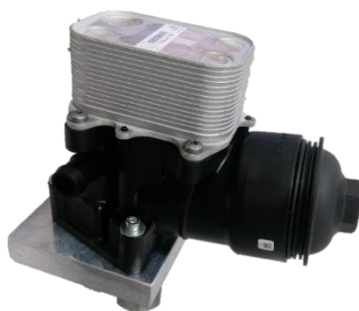
Image 1: Oil filter element HU 7008 z

After changing the oil filter element HU 7008 z, a leakage of the oil filter housing at vehicles with 1.6 and 2.0 TDI engines might occur.

No! The O-ring appears to be an obvious cause, but it isn't. Compared to the original gasket, the O-ring seems to be thinner, but both do have the same diameter of 3,5 mm (same measures).

When screwing down the housing cover after the change of the oil filter element, the maximum allowable torque is 25 Nm (+5 Nm). This should not be exceeded. This is best done using a torque spanner. If the indicated torque is exceeded, the housing cover can be deformed or the thread can be damaged. This can cause a leakage at the housing cover and loss of engine oil.

Using a torque spanner and oiling the new gaskets with clean engine oil, will prevent damage or leakage of the oil filter housing.
