## Service Info

# LuK Double Disc Clutches

## Transport damage due to incorrect handling

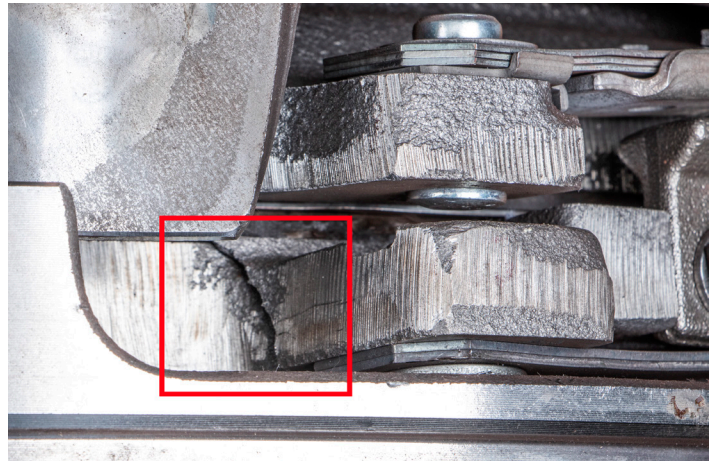
Image 1: Cam break at the fixture of the tangential leaf spring

The main cause of this damage is lateral impact loads that result from improper loading methods or inadequate securing of the load.

In most cases, these impact loads cause cam breaks at the fixtures of the tangential leaf springs (Fig. 1), which then lead to problems disconnecting the clutch. Furthermore, fragments of the cam or parts of the tangential leaf spring can suddenly work loose even at low speeds and cause serious damage to the bell housing. For this reason, a damaged pressure plate must not be installed under any circumstances because very high consequential costs can be expected.

- The condition of the clutch packaging on arrival must be more or less damage free. If the packaging has been damaged during transportation, conduct a detailed visual inspection on the clutch to check for the damage mentioned above
- Any impact loads on the clutch, especially lateral impact loads, must be prevented
- As the clutch is relatively heavy, it is worth using a suitable lifting device to handle the component
