Service Info

Bleeding process of CSC 510 0097 10

Modified hydraulic connection

Manufacturer: Dacia
Nissan
Renault

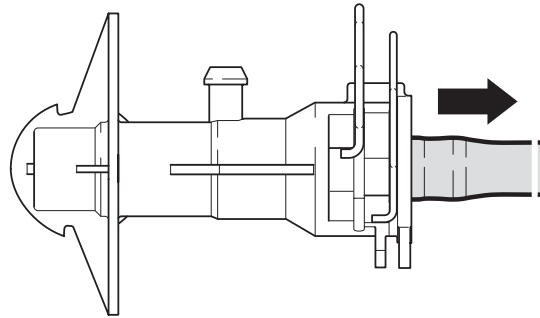
Photo 6: With the connector pulled out and the clips opened, the bleed hole is open

1. Open clip 2
2. Open clip 1
3. Pull the pipe out until it reaches the stop (Photo 6)
4. Connect the bleeding device and switch it on
5. Remove air until liquid discharge is free of bubbles
6. Close clip 1
7. Close clip 2
8. Push the pipe on until it reaches the stop (Photo 7)
9. Switch off the bleeding device and remove it

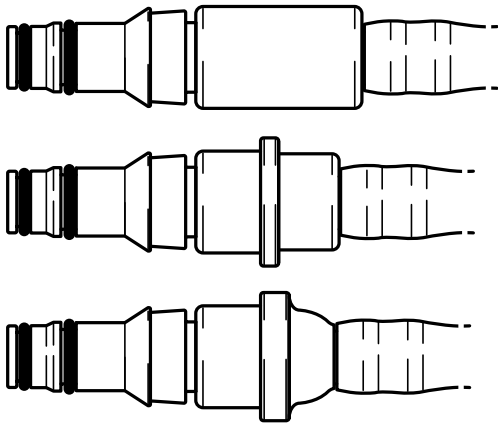
Photo 5: Vehicle-side connections with long flange

Bleeding procedure for vehicle-side connector with long flange (Photo 5):

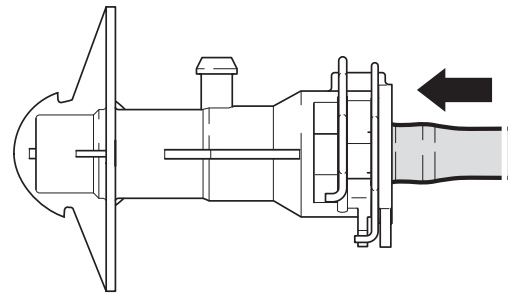
Photo 7: With the connector pushed in and the clips closed, the bleed hole is closed
