## LuK Service Info

# Clutch pedal malfunction

## Clutch pedal seizing up in the middle of its travel or dropping to the floor without actuating the clutch

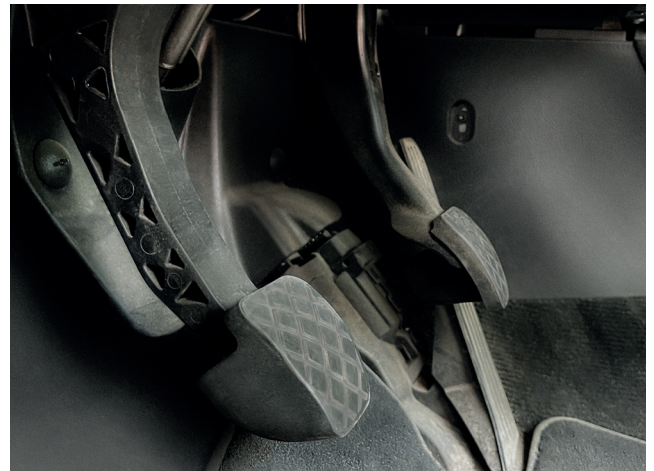
As part of our ongoing quality control, we have recorded that customers occasionally encounter a problem with the clutch pedal seizing in the middle of its travel (Image 1) or falling to the floor without actuating the clutch. This malfunction can occur intermittently or permanently. In this case, only correctly performed diagnostics will help to identify the cause of the malfunction. We recommend checking the condition of not only the clutch and the dual mass flywheel, but also the associated components.

Image 1: The clutch pedal hanging up in the middle of its travel

Pay attention to the clutch release system, especially the release bearing, master/slave cylinder, lever, clutch pedal support, proper bleeding and sufficient level of correct hydraulic fluid in the hydraulic system, etc.

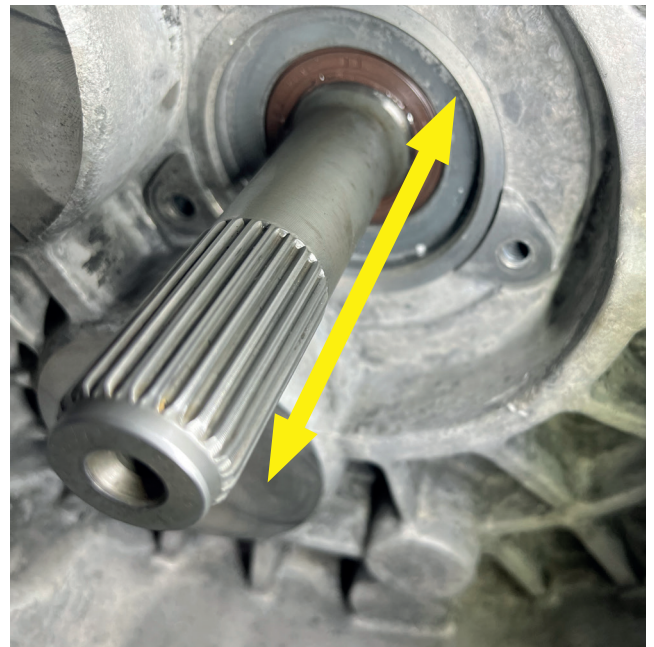
Also, check the condition of the gearbox input shaft, particularly its axial clearance (Image 2). The cause of such malfunction can be a worn bearing at the rear of the housing. It is necessary to repair the whole unit, eliminating the gearbox input shaft axial clearance. This can be carried out using an LuK GearBOX which is a unique repair solution created specifically for gearbox repairs and maintenance.

Image 2: Axial clearance of the gearbox input shaft

Please note that only correctly carried out diagnostics and repair with replacement of all faulty parts will solve the problem.
