AXLE STRUT OPEL VECTRA REAR AXLE

TECHNICAL INFO NO. 1057

Opel	Vectra B
Vauxhall	Vectra MKI

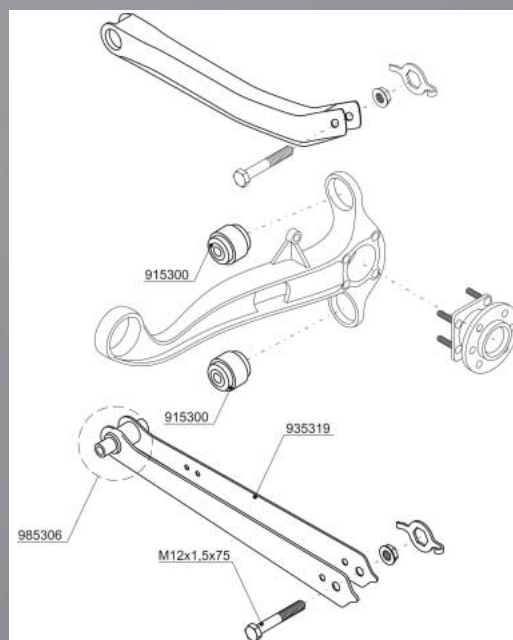
Fig. 1: Axle strut Opel Vectra rear axle

Cracks and fractures frequently cause failure of the lower rear axle strut in the Opel Vectra B. This is usually the result of corrosion in the struts, combined with stiff or seized rod ends on the wheel side.

Repairs that replace just the struts without the rod ends fail to eliminate the cause; this may possibly lead to renewed premature failure of the new struts with the same fault symptoms.

When changing the cross strut, always also replace the rod end. Please comply with the instructions issued by the vehicle manufacturer!

For this reason, it is vital for the rod end of the strut (RUVILLE Article 915300) to be replaced as well when changing the axle struts. The other rod end fitted to the wheel should also be checked to see whether it moves smoothly, and also replaced if necessary.

For further assistance in counteracting the corrosion problem, in contrast to the general market standard RUVILLE offers the struts in top quality zinc plating.
