Technical *Info*

Retrofitting of the V-ribbed belts on Renault 1.4 /1.6 16 V engines with K4J/ K4M air conditioning

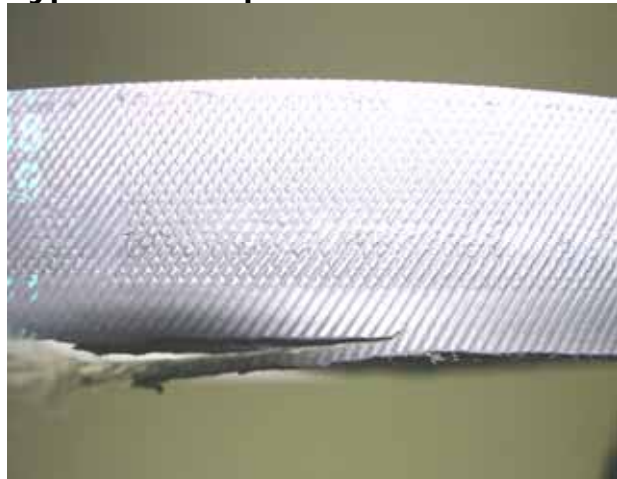
The belt is very noisy, wears quickly and exhibits signs of abrasion. Because of the sideways oscillation, the tensile member, including the ribs, might rip out of the belt. If a timing belt starts slipping as a result, this can, in turn, lead to serious engine damage.

The V-ribbed belt on older vehicles has six ribs (6 PK 1748).

Fig. 1
Type to be replaced

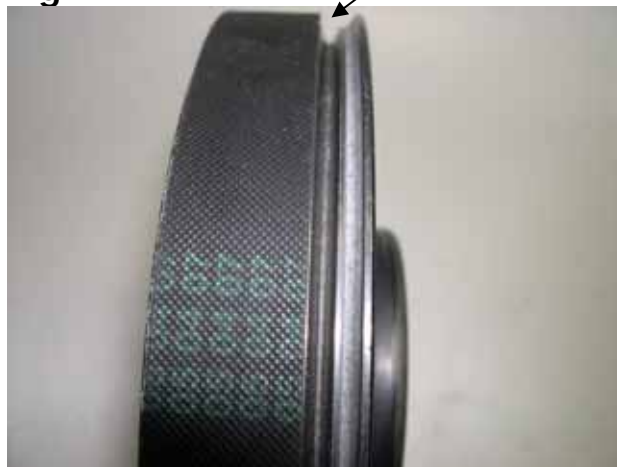
Fig. 2

The new belt has only five ribs (5 PK1750) to set the belt off from the engines more. According to Renault, this new belt should generally be installed.

The new 5-rib belt is placed only on the outer grooves of all belt pulleys; the inside groove remains free on all pulleys. In this connection, the generator's overrunning clutch should be checked to make sure that it is functioning perfectly and the hydraulic steering pump checked for axial clearance. (Misalignment!).

Before mounting the belt, remove any abrasion from the grooved pulley using a wire brush.
