Technical *data*

CT 1014 K3 retrofitting kit for diverse Opel/ GM 1.7 DTI (up to engine number 328703)

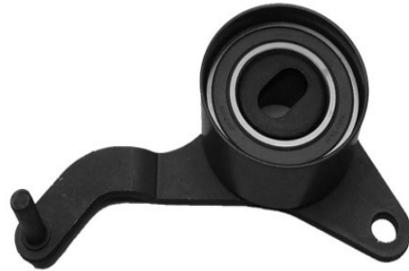
Fig. 1

According to "Opel TIS", the old, mechanical idler pulley from CT 1014 K1 can no longer be used. Across the board the new type is being installed instead (as is the case ex works as of engine number 328704).

old idler pulley from CT1014 K1

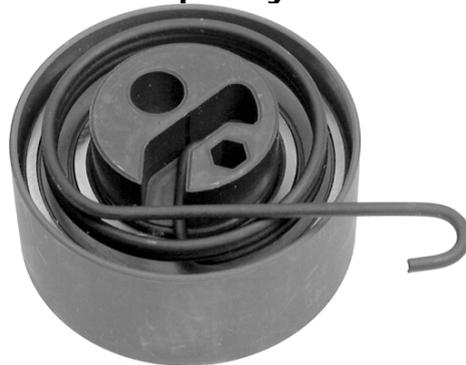
Fig. 2

The new pulley does not fit into the slot for the old idler pulley. The engine support bracket is now positioned at a slant to the engine and can no longer be screwed onto it.

new idler pulley from CT1014 K3

To mount the new pulley, an enclosed stay bolt has to be screwed in to the right of the injection pump wheel. This now serves as the catch for the modified pulley spring.

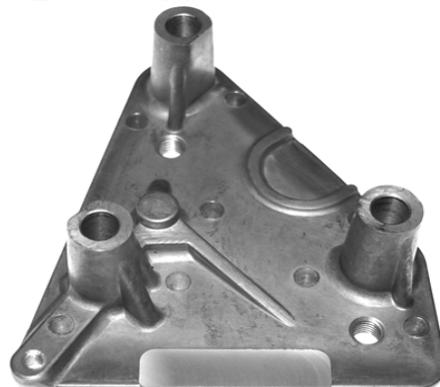
Fig. 3

engine support bracket

The old engine support bracket must also be replaced with the likewise enclosed new type. This is necessary because with the new pulley there is no longer any base plate, which also previously served as spacer plate for the engine retainer. Screws should be tightened to a torque of: **49 Nm**
