Technical *Info*

Mounting instructions for CT 984 K2 and CT1015 K2, e.g. Audi, VW 2.5 TDI V6

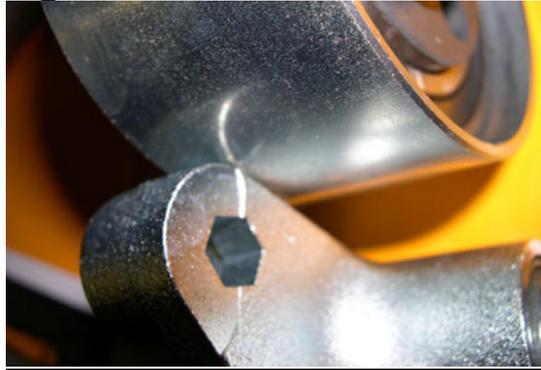
Fig. 1

The tension lever chafes against the tensioning pulley. (Figure 1) This can result in serious damage to the engine.

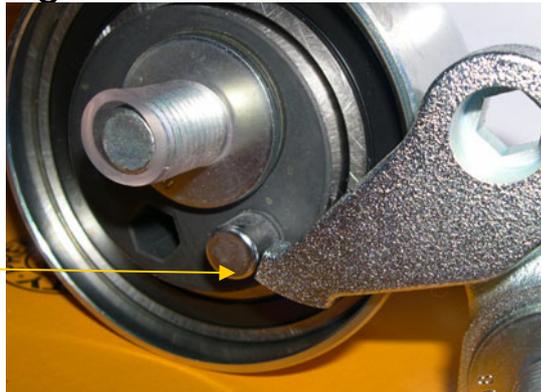
Fig. 2

Due to **improper** positioning during installation (Fig. 2), the tensioning lever comes into contact with the barrel jacket after the parts have been in operation only briefly. By way of illustration, the side facing the engine is shown here. (It is otherwise not visible.)
