An incorrect setting of the tensioner pulley can cause engine damage

PPE 1.6 HDi / BlueHDi, Ford 1.5 TDCi (article no. CT1203, CT1203K1, CT1203WP1)

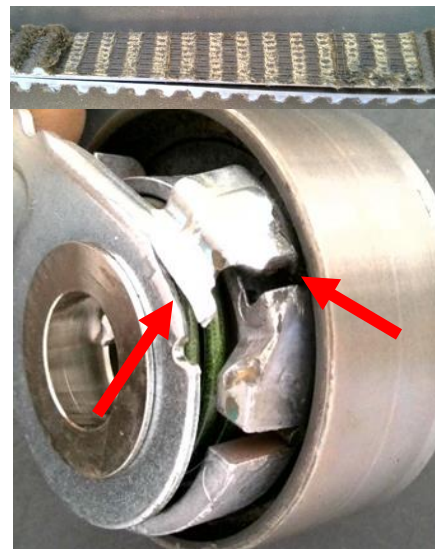
Teeth have been sheared off the timing belt, the tensioner pulley arrester body is torn and the full load stop is incorporated.

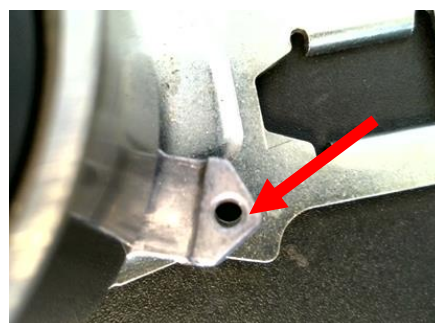
During the tensioning procedure, the hole in the tension indicator is brought into contact with the hole in the arrester body. As a result, the tension is set far too high and the full load stop is incorporated by the recurring clash with the arrester body until it finally tears or aborts.
