**Noise from the timing belt drive**  
**CT1134, CT1139 and all associated kits for Audi, Seat, Skoda and VW.**  
**Various models of 1.2–2.0L TDI common rail, EA189**

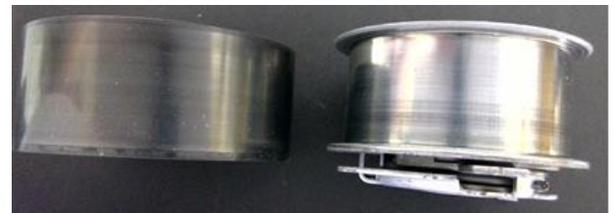
**Fig. 2**

When the timing belt drive is tensioned, not only fastening of the shafts (Figs. 4, 5 and 6) but also loosening the camshaft sprocket and the high-pressure pump sprocket (Figs. 4 and 5) are essential. Otherwise, the belt tension is not distributed over the entire belt drive. This results in incorrect contact pressure, which makes the pulleys noisy and damages the bearings. Clear indications of this fault are marks on the back of the belt (Fig. 1), stress lines on the pulley casings (Fig. 2), or belt material deposited on the pulleys (Fig. 3).

Follow the manufacturer's instructions when tensioning. The camshaft sprocket and the high-pressure pump sprocket must be loosened (Figs. 4 and 5) in order to distribute the tension over the entire belt drive.
