Cooling system cannot be bled properly on vehicles with an electrically/pneumatically controlled water pump

Examples: Audi / Seat / Skoda / VW 1.4I, 1.6I, 2.0I TDI - CT1168WP1

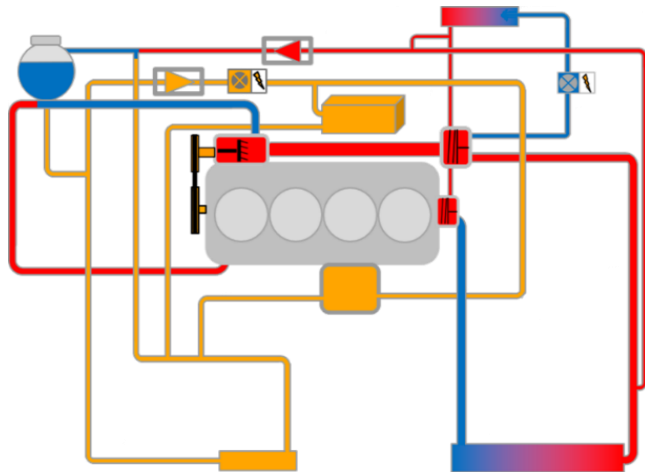
Noise or temperature problems as a result of incorrectly bled cooling system. There is still air in the system following replacement of the electrically/pneumatically controlled water pump.

On vehicles with an electrically/pneumatically controlled water pump, the cooling system must be bled after being refilled using our vacuum filling device (Tool Box W01) and an additional diagnostic device with the necessary functionality. The reason for this is the thermal management system, which has additional valves that supply different heating circuits. The valves need to be opened for bleeding so that all heating circuits can be opened and bled.

It is essential to follow the vehicle manufacturer’s instructions and information when carrying out repair or maintenance work on the cooling system. The cooling system must always be bled with the help of a vehicle diagnostic tester using its “guided” function.
