Teeth are sheared off the timing belt during the starting process or after a short mileage. CT1140K2 and CT1140WP2.

Various diesel engines Euro 6: Opel 2.0; Citroen/ Peugeot 2.0/ 2.2 Blue HDi; Ford 2.0 TDCi / ECO netic / ECOBlue; Toyota 2.0 D4d

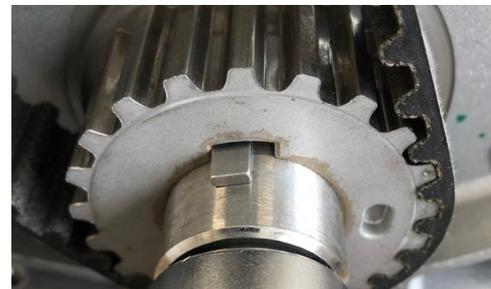
The belt drive is equipped with an oval crankshaft sprocket to reduce power peaks in the belt drive. The crankshaft sprocket is mounted loosely/ movably on the shaft and can be twisted without using the special tool. This, in combination with an incorrectly mounted high-pressure pump, leads to greatly increased force peaks and can cause the timing belt to fail.

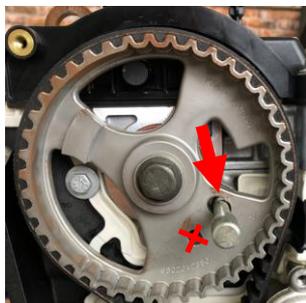
Fig. 1

8mm (Fig. 1) > 1st cylinder TDC for changing the timing belt

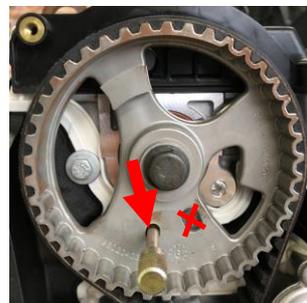
Fig. 2

6mm (Fig. 2) > approx. 75° further, for disassembly and assembly of the injection pump.

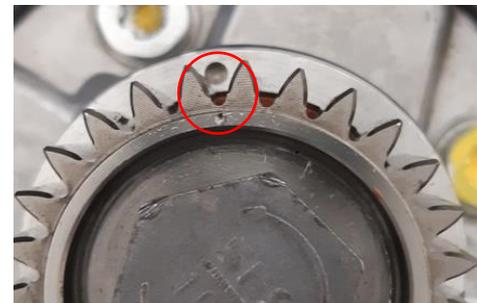
Fig. 3

The high-pressure pump itself has markings on the pinion as well as on the housing (**Fig. 3**), which must be aligned for correct installation. If the high-pressure fuel pump was removed and installed in addition to the timing belt change, first install the timing belt completely and then the high-pressure pump.

If the high-pressure fuel pump was removed and installed in addition to the timing belt replacement, it is essential to ensure the correct installation sequence! First fit the timing belt completely and then the high-pressure pump. The tensioning process must be carried out according to the vehicle manufacturer's instructions, using all the special tools intended for this purpose.

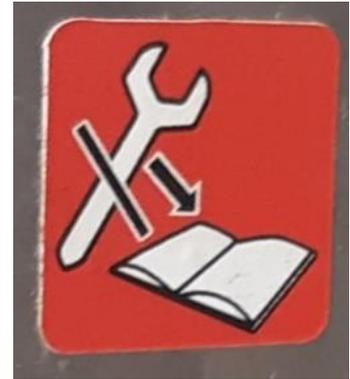
The difficulty is finding the markings. Used pumps are sometimes wetted with black oil on the gear wheel and the special features of this pump are simply not known to many workshops. A sticker on the injection pump indicates that the special installation instructions must be observed.
