Different versions of the tensioner pulley in the timing belt kits CT1139K2, CT1139K3PRO, CT1139WP2, CT1139WP6 and CT1139WP8PRO, used in various 1.2-2.0L TDI EA189 common-rail engines from Audi/Seat/Skoda/VW

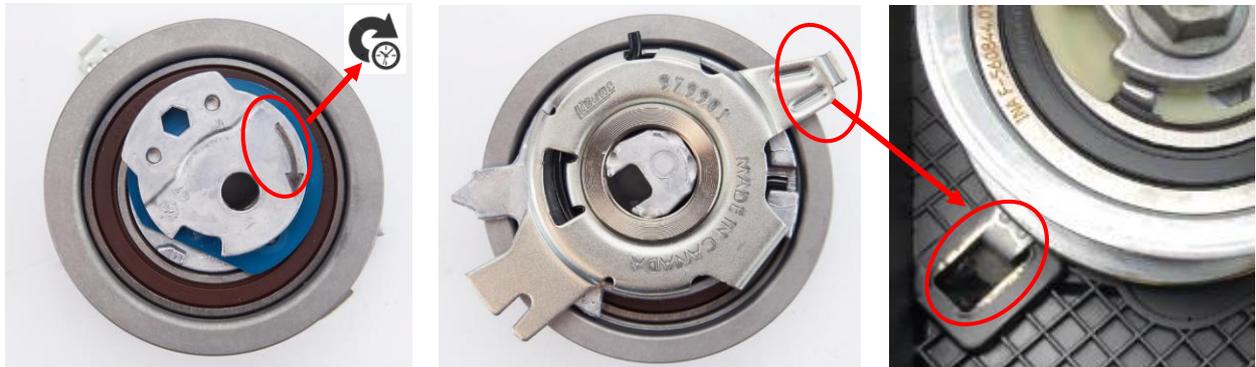
Picture 1 Litens / INA version

The supplied V56349 tensioner pulley looks different from the pulley fitted in the vehicle. It seems that it cannot be tightened in the way described in the fitting instructions.

The vehicle manufacturer fits two different versions of the tensioner pulley. The Continental kit may also contain either of the two versions shown in picture 1 and picture 2.

The two versions of the tensioner pulley are interchangeable and can be used in all the engines indicated by the vehicle manufacturer. It is important to follow the vehicle manufacturer's fitting instructions as the method of installation and tensioning direction differ. The Gates version is tightened in a counterclockwise direction and the Litens / INA version in a clockwise direction. The tensioning direction is clearly marked on both pulleys (arrow on the outer face of the tensioning plate).
