## Tensioner pulley outer ring has become displaced.

### CT1078K1, CT1178K1 for Opel/Vauxhall/Chevrolet 1.7D/CDTI

(A17 DT/DTC/DTE/DTF/DTI/DTJ/DTL/DTN/DTR/DTS, Z17 DT/DTH/DTL/DTJ/DTR, LKR, LUD)

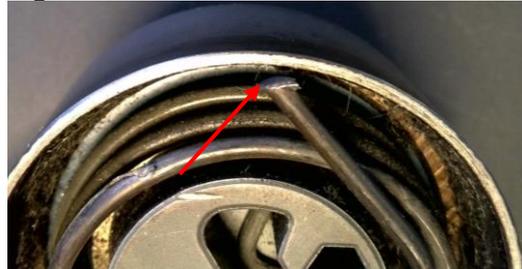
Fig. B

Noise from the timing belt drive. Misalignment in the belt drive. Timing belt jumps or is torn. One edge of the timing belt is worn down along its entire length (**Fig. A**). The tensioning spring of the tensioning pulley has been partially or completely ground through (**Fig. B**).

The belt drive is subject to unacceptable tension and heats up excessively. Incorrect tensioning results in the timing belt becoming misaligned and running to one side. Due to the excessive heating, the running surface of the tensioning pulley separates and shifts on the ball bearing (Fig. C). As a result, the tension spring is worn through (Fig. B).

Depending on the engine code, the tensioning pulley must be finally tightened either at 0° or 60° before TDC. The vehicle manufacturers installation instructions must be followed for the correct engine code.
