**Adjustment cam on tensioner pulley fractures during tensioning process.  
Timing belt kits CT1168K1/ K2/ WP1/ WP2/ WP7/ WP9/ K6PRO/ WP8PRO  
VW, Audi, Seat, Skoda 1.4–2.0 TDI common rail, EA288**

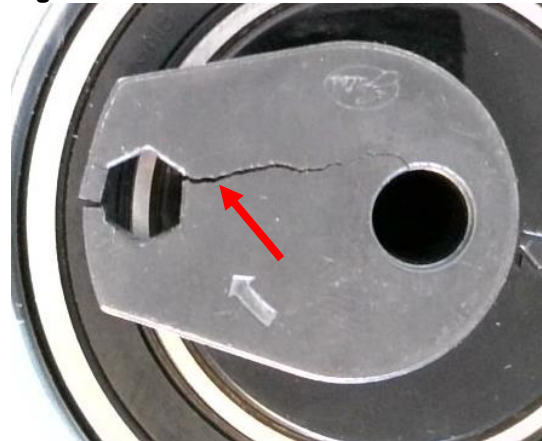
**Fig. A**

Adjustment cam on tensioner pulley fractures during tensioning process (**Fig. A**).

The fastening nut is overtightened during assembly. As a result of this, the nut turns together with the eccentric cam during tensioning, subjecting it to an even greater load. This produces too much resistance, causing the adjustment cam to crack (**Fig. A**).
