### ContiTech

#### Change in manufacturer of tensioning pulley V55881 from CT 1148 K1 for various Fiat Ducato / Iveco Daily models; all 2.3 D

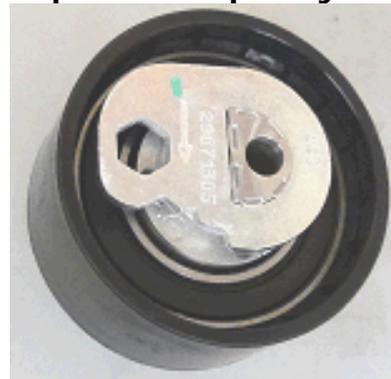
**Fig. 1**  
Superseded pulley

The manufacturer of the pulley (Fig. 1) has changed. Design changes have occurred as a result (Fig. 2).

The new pulley can be used in place of the previous version without restriction.

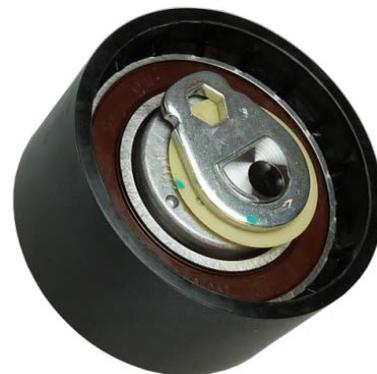
**Fig. 2**  
New tensioning pulley

The new pulley has a different plate plus setting mark.
