ContiTech

Installation tip for timing belt kits CT1037K2 and CT1037WP1
for various Peugeot 807 and Citroën C8 2.2 HDI diesel engines

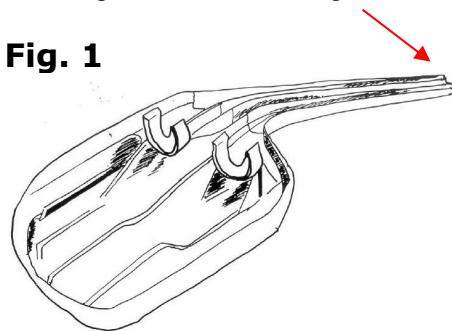
Fig. 1

Rainwater runs into the timing belt drive and causes corrosion and icing, resulting, in the worst-case scenario, in engine damage.

The drainage ducts can briefly overflow in the event of excessive water ingress.

Discharge aimed behind engine

Citroën and Peugeot have developed a drain trough with part number 8248.71 (**Fig. 1**), which prevents rainwater running off the windshield from getting into the timing belt drive. Slide the drain trough under the cooling circuit expansion reservoir (see **Fig. 2**) and attach it using the mounting clips (**Fig. 3**). Ensure that the drain trough slopes downwards towards the rear.
