Technical *Info*

Failure of the idler roller from CT 1079 K1 due to overheating (Opel, Renault, Saab engines 3.0 DTI V6)

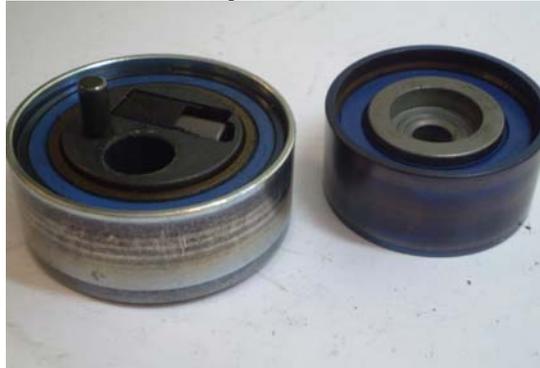
The belt fails due to overheating shortly after the kit is installed.

Overheated parts

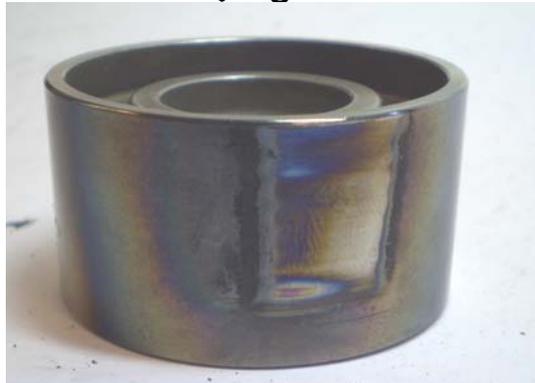
The **idler pulley** is blocked due to improper installation!

This results in overheating of the belt, which transmits heat to the other parts, in turn causing the belt drive to fail.

The **idler pulley** is blocked when the **wrong side** of the pulley is attached towards the engine block.

1 idler pulley mechanically blocked (engine side top)

Solution: The idler pulley between the camshafts must be installed with the raised inner flange towards the engine! If this is not done, the pulley is positioned incorrectly and as a result, is blocked (see the signs of rubbing off the center of the belt).
