Technical *Info*

Belt failure due to improper installation of the tension spring: CT 942 K1 (Hyundai 1.4-1.6-I/16 V, various models)

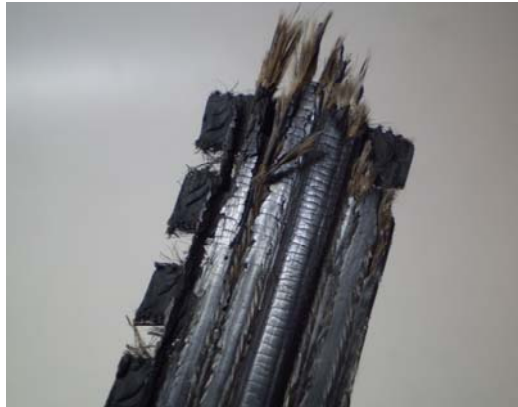
The belt drive fails due to a torn timing belt.

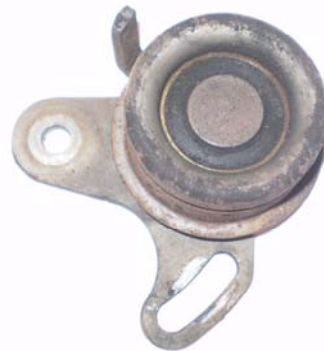
The back of the timing belt became overheated because the tension pulley was prevented from turning freely.

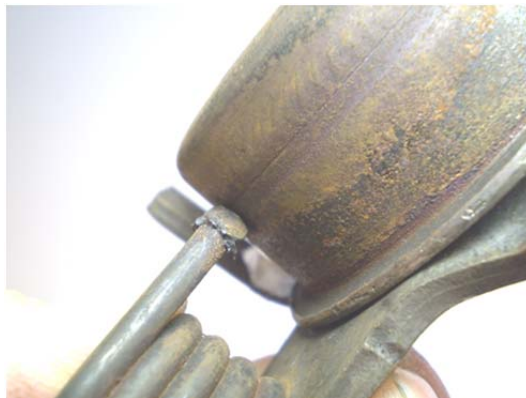
Otherwise it may come into contact with the surface of the bearing and cause the bearing to become blocked.

The correct installation position of the tension spring must always be checked.
