Technical *Info*

Timing belt kit CT 884 K1 / CT 990 K1 and K2, various Opel and Saab 2.5 / 2.6 / 3.0 and 3.2 V6

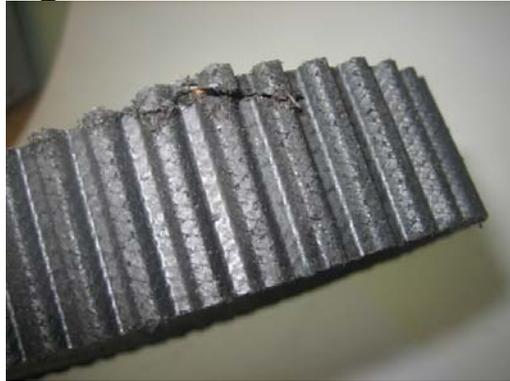
Fig. 1

After a short period of operation the timing belt jumps because of a lack of tension.

The idler pulley screw has snapped and caused a sudden loss of tension.

The factory default setting of the idler pulley with a prefitted screw may not be used. The screws of both idler pulleys must be tightened to **40 Nm** in accordance with the **setup process** specified by the manufacturer.
