# SWAG 50 79 0004

to fit:  
 VW Sharan (ref. no. 7M3 411 317 E)  
 Seat Alhambra (ref. no. 7M3 411 317 E)  
 Ford Galaxy (ref. no. 1 361 653)

## Connecting rod

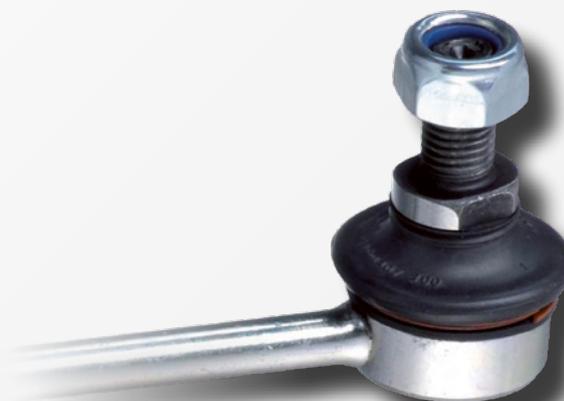
The parts cause noise whilst driving.

Due to its design and location (refer to picture 1) the connecting rod is subject to strong external forces. Both joints are completely exposed to water spraying up from wet roads. A damaged rubber boot (refer to picture 2 and 3), i.e. damaged by road debris, makes it easier for water and dirt to find its way into the joints. Consequently the protective grease will be washed out and the ball pin oxidises. As a result of this, the roughened ball surface increases wear to the plastic ball cup (refer to picture 4), which leads to the joint moving around and causing noise.

- High performance rubber compound ensures the required flexibility
- Shaped to seal the joint system at each angle
- Proven grease resistance

- The locking rings are specifically designed for this application, in order to support the sealing characteristics of the rubber boot

- Use of high performance grease for the ideal lubrication of the ball cup (refer to picture 7) and the ball pin
- Corrosion protection for the whole system
