## SWAG 60 10 5688

To Fit:  
Renault Clio 3

## Wiper motor

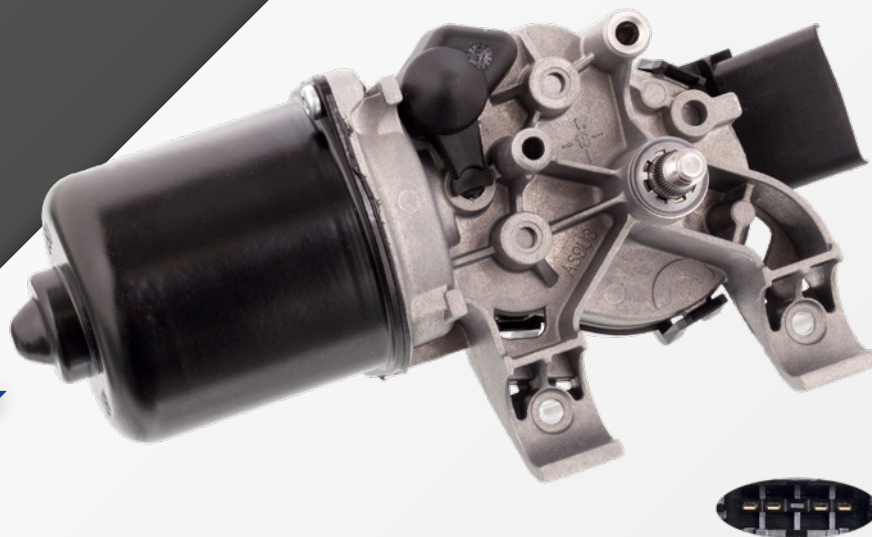
The wiper motor is submerged in rainwater and fails due to water ingress.

Over time, road debris and fallen leaves can block the water drain tubes in the scuttle panel below the front windscreen. This causes the area to fill with rainwater - submerging the wiper motor and linkage. This constant immersion in water gradually leads to the penetration of the casing and, ultimately, to motor failure.

Remove the faulty wiper motor and linkage. Clean out the drain tubes using a suitable piece of wire and flush through with water to make sure that the one-way valve (rubber flap) is clean and not sticking. Check that the wiring loom connector is free from corrosion; clean or replace as necessary.

Before replacing the wiper motor, check that the wiper linkage is in good working condition and not seized, or showing any excess 'play' in the joints. If found to be seized or sufficiently 'worn', replace the linkage as well as the faulty wiper motor.
