# SWAG 40 93 3044

to fit:  
Opel 2.0l turbo and 2.2l petrol engines

## Chain tensioner

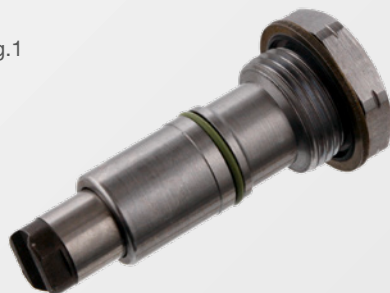
Fig.1

Although all the components have been correctly fitted, rattling noises are often present (caused by the elongation of the timing chain). If the timing chain slips as a result, then the engine can run erratically and misfire and in the worst case cause extensive engine damage. This affects Z22YH and Z22SE engines.

A blocked timing chain tensioner. The original version (repl. no. 0636549) of the chain tensioner had a green O-ring and a rubber-lined washer (see Fig. 1). The vehicle manufacturer fitted this version in the engines mentioned above. A modified chain tensioner has been used in production since model year 2009.

Old
