SWAG 11 10 4929

To fit: MINI Cooper S and Cooper JCW (R52, R53)

TVD Pulley for crankshaft

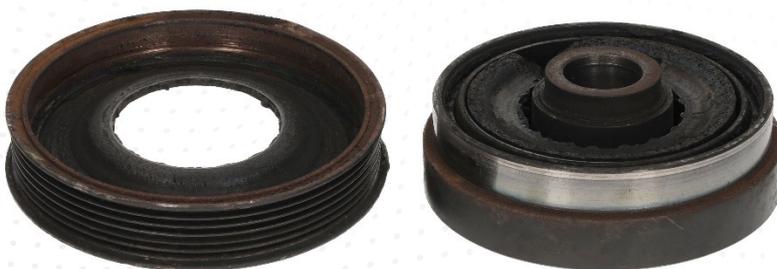
Figure 1

The torsion vibration damper (TVD) crankshaft pulley rubber bonding has deteriorated to the point of failure. This disrupts the auxiliary belt drive to the alternator, air conditioning pump and the supercharger. (Fig.1)

Due to the auxiliary belt not running correctly, the supercharger is not being driven or rotating properly. Therefore, the engine is not receiving the correct air/fuel mixture, logging fault code P1688, which can be misleading in diagnosing this fault.

Check the condition of the auxiliary belt drive system, including the belt, tensioner, all pulleys and the TVD. Replace all damaged and worn parts as necessary and clear any fault codes using a suitable diagnostic tool.
