## SWAG 30 10 3078

Audi, Seat, Skoda, Volkswagen

1.6 &amp; 2.0 TDi engines

## Water Pump

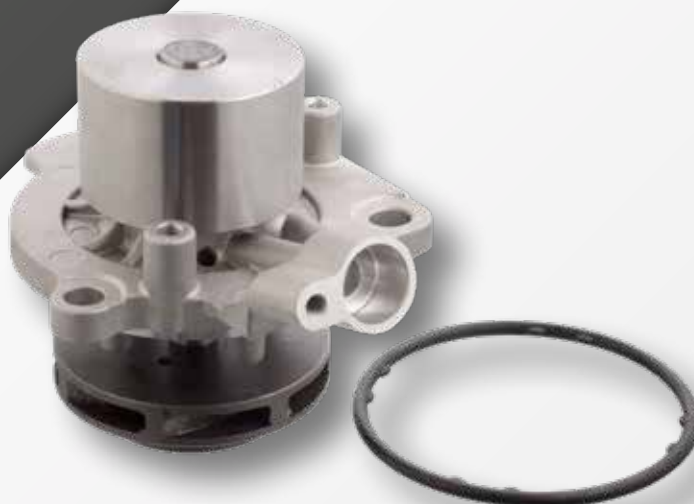
Engine overheating, coolant temperature gauge reading over 110° C and poor interior heater performance. Also cooling system fault codes maybe logged in the engine control unit.

The water pump fitted to these vehicles has an ECU controlled collar, which interrupts the coolant flow to make the engine more thermally efficient. However, the control collar can become seized, or the plastic impeller can break up or come away from the shaft.

Ensure the engine is cool, then remove the coolant filler cap. Remove the small pipe to the coolant header tank and hold this over the filler neck of the header tank, there should be a small trickle of coolant flowing with the engine at idle. This should increase in flow when the engine speed is increased. If the flow rate does not increase, this would suggest a faulty water pump.

Replace the defective water pump with SWAG 30 10 3078, this is a conventional water pump, which eliminates the potential failure caused by the control collar. The solenoid valve must be removed from the old pump and fitted to the new pump. This is so the engine management system can recognise it. Failure to replace the solenoid valve will log an engine management fault.

Fill the cooling system with the correct coolant, then vacuum bleed the cooling system. Finally carry out the cooling system bleeding procedure, using a suitable serial diagnostic tool, to expel all the air from the cooling system.
