SWAG 30 92 1764

to fit:
 Seat Cordoba,
 Seat Ibiza II, III (1.4 16V AFH, 1.0 16V AVZ)
 VW Polo 3 (1.4 16V AFH)

Repl. no. 036 109 243 J

Timing belt tensioner

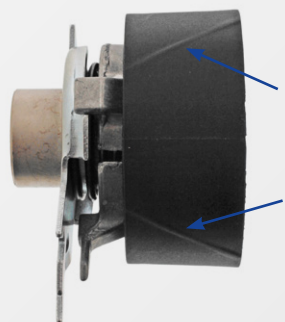
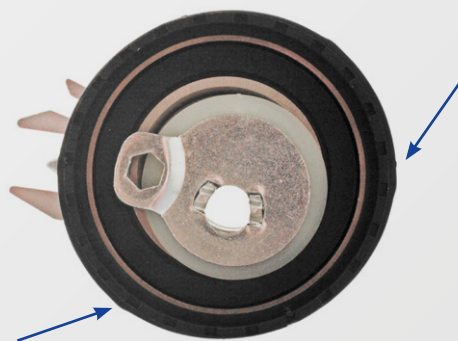
This noise-optimised belt tensioner has been developed specially for the applications outlined above. The running surface of the belt tensioner has diagonal elevations (see photos). It is deliberately like this to ensure that the timing belt runs more smoothly. The uneven running surface reduces vibration of the timing belt. At the same time, it also means a longer service life for the timing belt.

The running surface of the tension roller with diagonal elevations is not a production fault! The tightening torque of the tension roller screw is 20 Nm.

SWAG recommends using timing belt tensioner SWAG 30 92 1764 (repl. no. 036 109 243 J).
