SWAG 33 10 4355

To Fit: Mini R55, R56, R57, R58, R59, R60, R61

Engine: N12 B16A, N14 B16A, N14 B16C, N16 B16A, N18 B16A, N18 B16C

Thermostat with Housing, Seal, and Temperature Switch

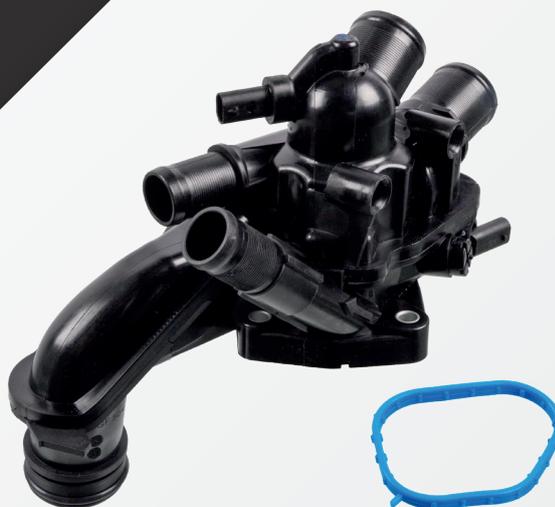
The engine is difficult to start or will not start at all, is unable to reach operating temperature, and there is a lack of heating in the passenger compartment.

Illumination of the coolant temperature warning lamp, engine coolant discharging from the expansion bottle (with it showing a reduced level), and the presence of coolant under the vehicle.

Engine cooling fan continues to run for an extended time after the engine has been switched off and the engine warning lamp is illuminated - related to the symptoms listed above.

The vehicles listed above can suffer from several issues related to the engine cooling system, the thermostat, or the housing. These include the following: the thermostat incorporated into the coolant outlet housing becomes stuck in the 'open' position resulting in the engine failing to reach operating temperature, the thermostat becomes stuck in the 'closed' position causing the engine to overheat, or coolant leaks; the latter caused by the original polyamide material of the housing aging under the influence of constant engine heating and cooling cycles and vibration, eventually leading it to distort and crack.

Due to the issues and symptoms listed above, the vehicle manufacturer has modified the design of the thermostat housing. The updated design benefits from an electronically controlled thermostat, a reinforced structure, and a new configuration of the sensors - which may require an additional 2 x 2-way connector (O.E. 12 51 8 611 289 for vehicles built up to 30/06/2012 or 12 51 8 614 952 for vehicles built 01/07/2012 > 31/01/2013), subject to original vehicle equipment.

Diagnose and identify any fault codes which are causing the warning lamps to illuminate. Replace the faulty coolant thermostat housing, fill the cooling system with fresh coolant, and bleed the air from the system. Note: when replacing the thermostat housing check all other coolant pipes for their condition and replace as necessary.
