# SWAG 33 10 5966

To fit: Mazda 2 2016-, 3 2014-2016, 6 2014-2016,  
CX-3 2016-, CX-5 2013-2016, CX-9 2016-

## Anti Roll Bar Bush

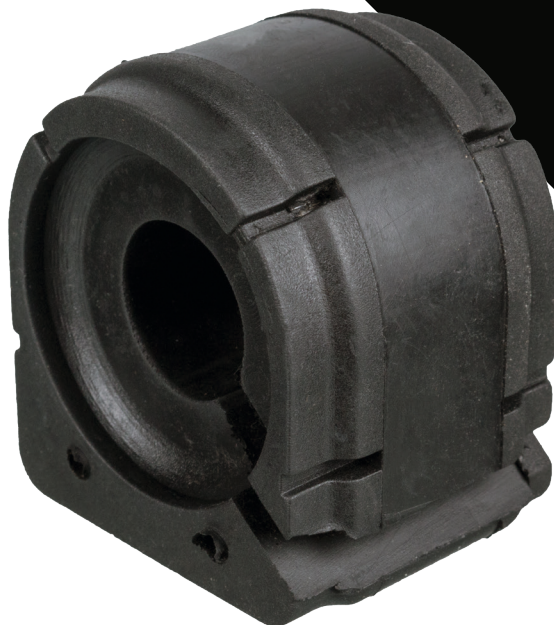
Squeaking noise from the suspension system when travelling over uneven surfaces after the anti roll bar bushes have been replaced or lubricated.

The bushes for the vehicles listed above are designed to be of a grip type which have been incorporated for noise prevention purposes. If any type of grease or lubrication is applied to the bushes during installation, it may create noise due to the bushes slipping on the anti roll bar.

To prevent noise from occurring, never apply any type of grease or lubrication to the front or rear anti roll bar bushes.

When replacing, only install these anti roll bar bushes when clean and dry and do not use any lubricant during the installation process.
