To fit: Various models in the VAG range fitted with 1.8 & 2.0 TFSI engines.

Water Pump with Thermostat Housing

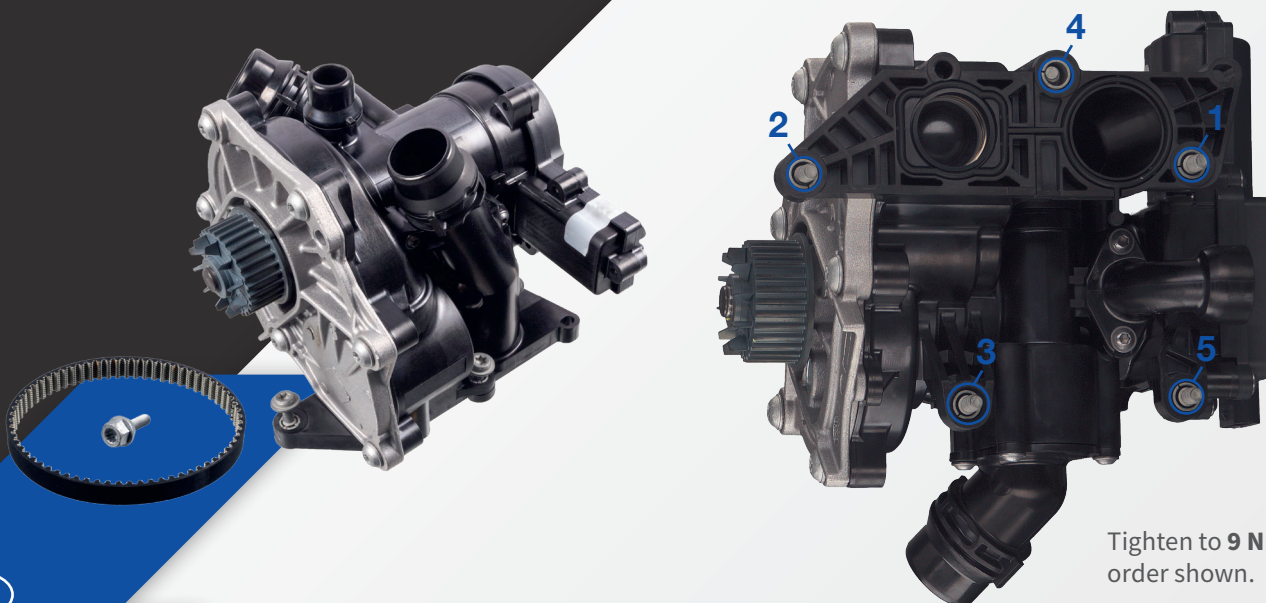
Tighten to **9 Nm** in the order shown.
