Water pump

fits Audi A6/avant/quattro, Audi 100/avant, VW LT, VW T4/syncro

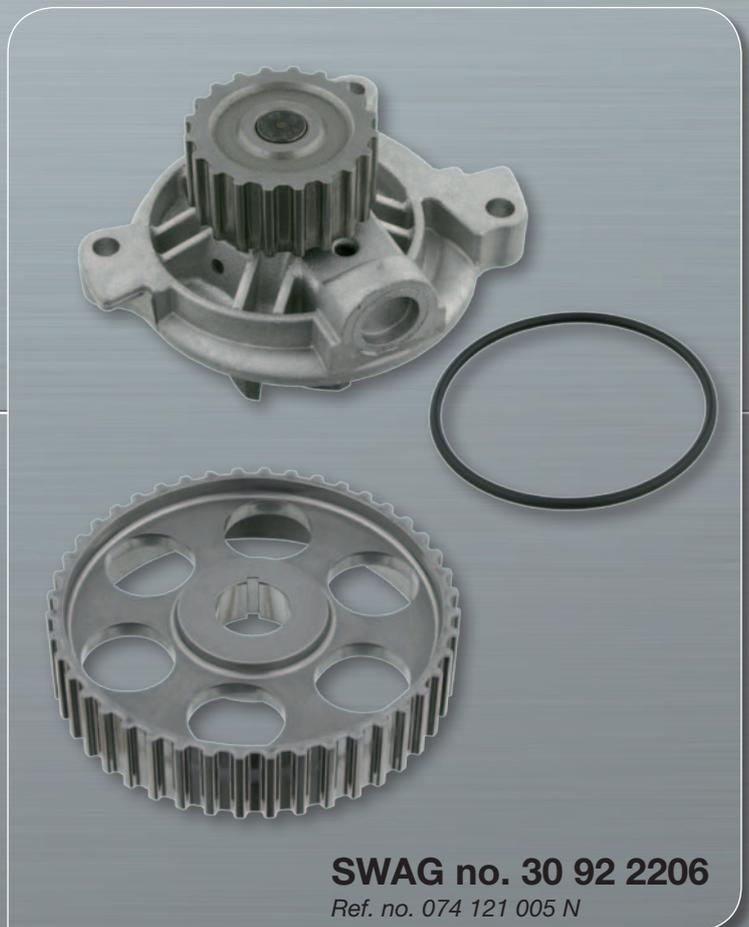
SWAG no. 30 92 2206

Premature failure of the water pump bearing and/or damage in the whole belt drive area, e.g. torn timing belt.

In 5-cylinder engines, the timing belt drives the water pump. The 18-tooth water pumps have a drive wheel that is too small and are overloaded by rotation speeds that are too high. These high loads can lead for example to a faulty water pump bearing. This in turn can lead to the whole pump seizing. It is therefore inevitable that damage will occur in the whole belt drive area, e.g. a tear in the timing belt.

The water pump has been improved. Now with 20 teeth instead of 18 and a larger drive wheel, the rotation speed is lower and wear on the water pump bearing is reduced. The water pump can now withstand the load.

Important: In petrol engines, the camshaft gear also has to be replaced when changing to the new water pump with 20 teeth. The SWAG 32 98 9108 camshaft gear cancels out the „timing shifts“ due to the larger water pump wheel.

It is imperative when changing the timing belt to replace the water pump at the same time!
