Loss of Direction

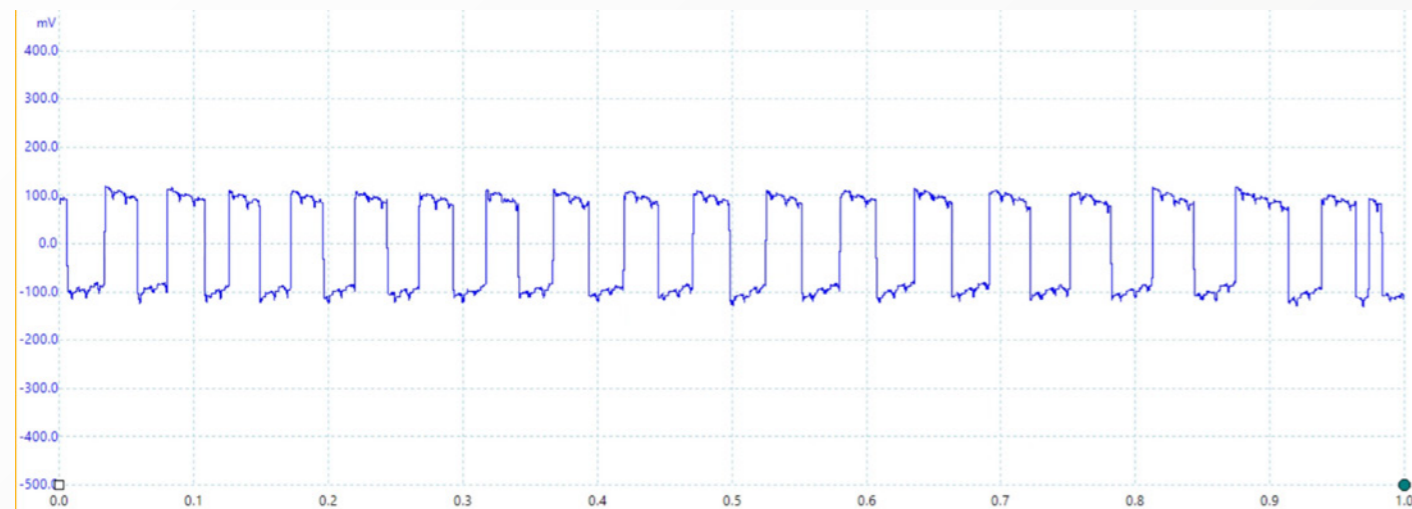
Figure 1

With the vehicle returned to the workshop, an oscilloscope was connected to the left rear wheel speed sensor to check the integrity of the signal in order to see if this was a simple case of a faulty sensor. On checking the signal, there was an inconsistency in the square wave signal. (Fig.1)

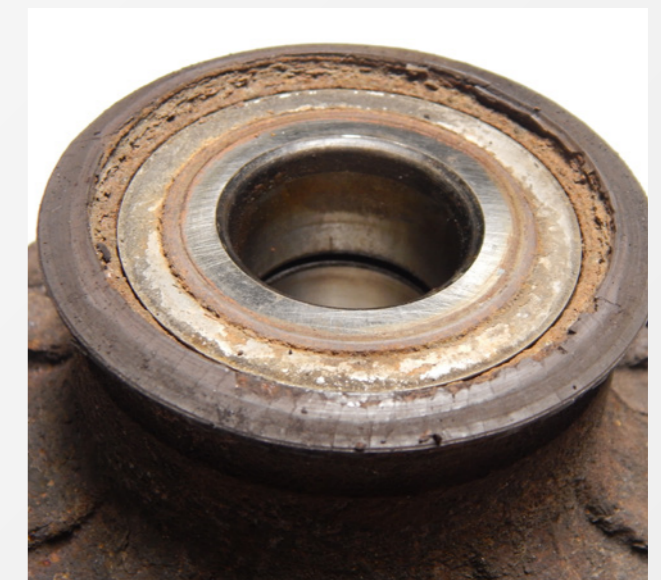
Figure 3

With the wheel bearing assembly removed from the stub axle, it became obvious what had been causing the issue. Corrosion between the ferrous metal of the wheel hub and the magnetic reluctor ring had caused distortion to the reluctor, causing cracking of the magnetic ring and a narrowing of the air gap between the reluctor and the wheel speed sensor. This was the primary fault with the vehicle. (Fig.3)

The SWAG wheel bearing kit (32 92 3320) was required as the replacement part, along with a wheel speed sensor (32 92 3810), because it had sustained some light damage from the distorted reluctor ring.

The new bearing assembly and the wheel speed sensor were fitted to the car, along with the refitting of the brake assembly and wheel. Once this was completed, the steering wheel angle sensor reset could be carried out. This consisted of road testing the vehicle with an assistant to operate the diagnostic tool. This involved driving straight at no less than 20 km/h, turning the steering wheel at least 15° to the left and then to the right and then stopping the vehicle. Then, the steering was turned completely to the left and was held for at least 3 seconds, then back to the centre. This was followed by the turning of steering all the way to the right and then being held for 3 seconds and back to the centre again. Once this procedure was carried out, the sensor was reset and all systems were fully functioning again.
