# All partied out in Ibiza

This example relates to a Seat Ibiza with the three cylinder 12 valve engine.

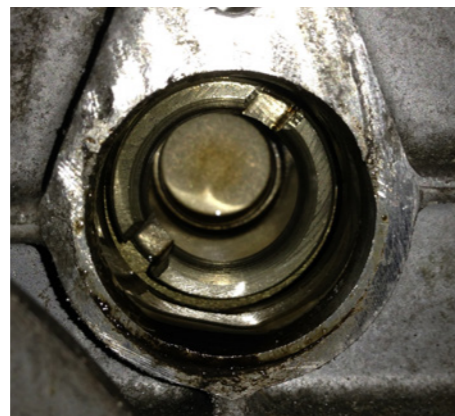
Image 1

Carrying out a quick visual inspection, it was instantly possible to tell that the timing chain had jumped. The exhaust camshaft (Fig.1) was clearly not lined up with the horizontal castings on the cylinder head, where the inlet camshaft was. (Fig.2)

The cause of poor performance and stalling was due to the camshaft timing being out of synchronisation, causing inconsistent valve timing.

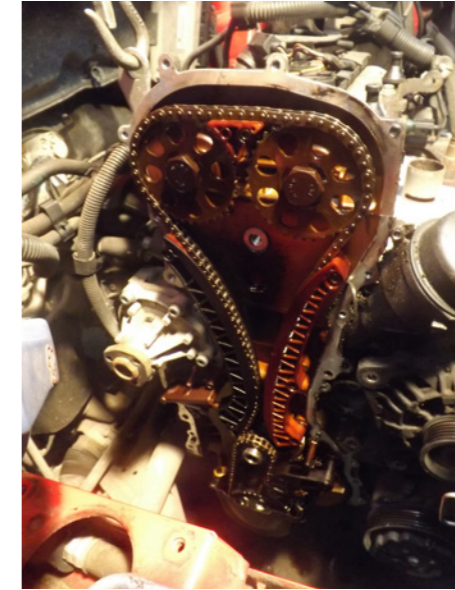
Image 3

After removing and inspecting the timing chain, it was found that the timing chain, sprockets and guides were all worn. This was causing the timing chain to slip, leading to the exhaust camshaft moving two teeth and causing the poor running issues. A new timing chain kit would be required. (Fig 3)
