# febi 46748

To fit:  
various Volkswagen, Audi, SEAT and Skoda models

## Expansion bottle with sensor

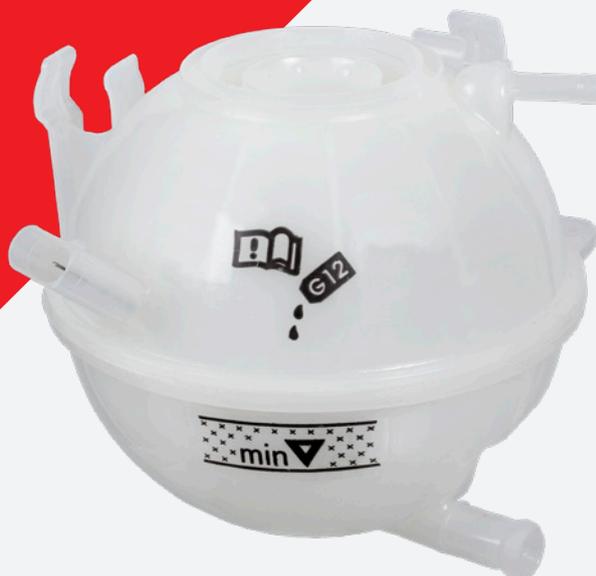
The message 'STOP', 'check coolant', or the low-coolant warning lamp is flashing on the instrument display - depending on vehicle model. Upon checking the coolant level, the level in the expansion bottle is correct and there are no signs of coolant leaks.

Over time, contaminated coolant causes deposits to build up on the submerged contacts of the coolant level sensor within the expansion bottle. This affects the electrical resistance value of the sensor and, therefore, gives an incorrect reading of the coolant level. These contacts can be seen by looking through the expansion cap aperture. Coolant can also migrate into the electrical connector; this can be identified by a crystalline build-up in the electrical connector caused by a capillary action into the wiring harness. If this has occurred then the wiring harness will have to be assessed to make the appropriate repair.

Allow the engine to cool before working on the cooling system and then drain the cooling system of the old coolant.

Remove the two expansion tank retaining bolts and disconnect the electrical connector. Then, remove the attached hoses to remove the old part.

Fit the new febi expansion bottle (46748) along with a new cap (103522), using the two retaining bolts. Connect the electrical connector and the hoses. Refill the cooling system with fresh coolant mixture or pre-mix into the expansion bottle of the recommended coolant type for the vehicle. Finally, bleed the cooling system of any air.
