Various Chrysler, Dodge and Mercedes-Benz models

Intake Manifold Repair Kit

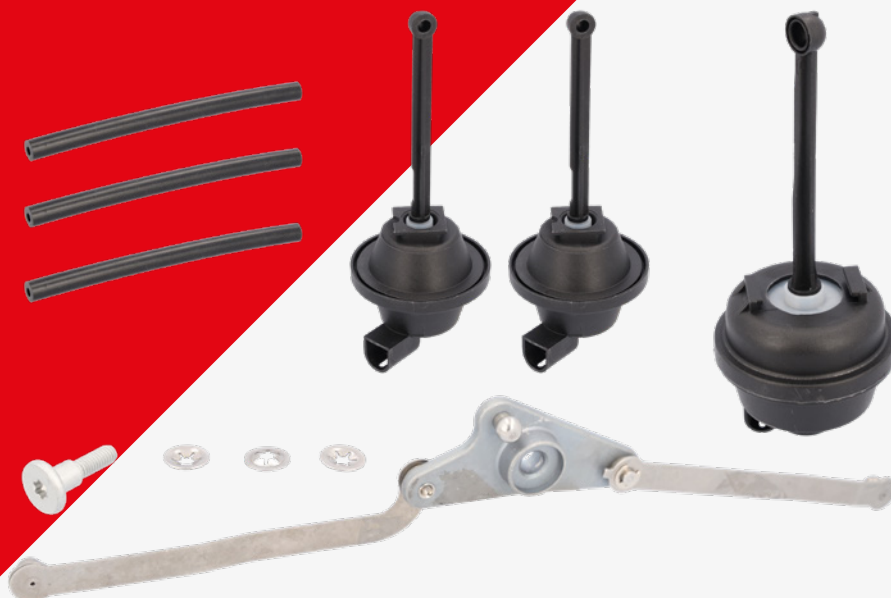
Lack of power, poor engine performance, swirl flaps not working, cam control mechanism broken, engine management warning lamp illuminated.

The intake manifold itself is not the cause of these problems, instead they are the result of a hose in the engine breather system leaking.

With age and load the hose in the engine ventilation system that is located above the swirl flap cam control mechanism can begin to fracture and leak. Over time oil drips onto the cam control mechanism below which causes the original plastic linkage to deteriorate and become porous, eventually leading it to break.

If the original plastic cam control mechanism is broken or weakened by the oil leaking from the hose above then it must be replaced. If the manifold is serviceable and can be reused then the broken or weakened linkage should be replaced with febi Linkage and Valve Repair Kit 188691 or 188709 – both include a stronger metal linkage. Alternatively, febi offer the complete manifold 48381 - which also includes the stronger metal linkage - for a comprehensive repair.
