febi 102440, 107345

Mitsubishi Montero, Pajero and Shogun models fitted with 4M41 diesel engine.

Timing chain kit

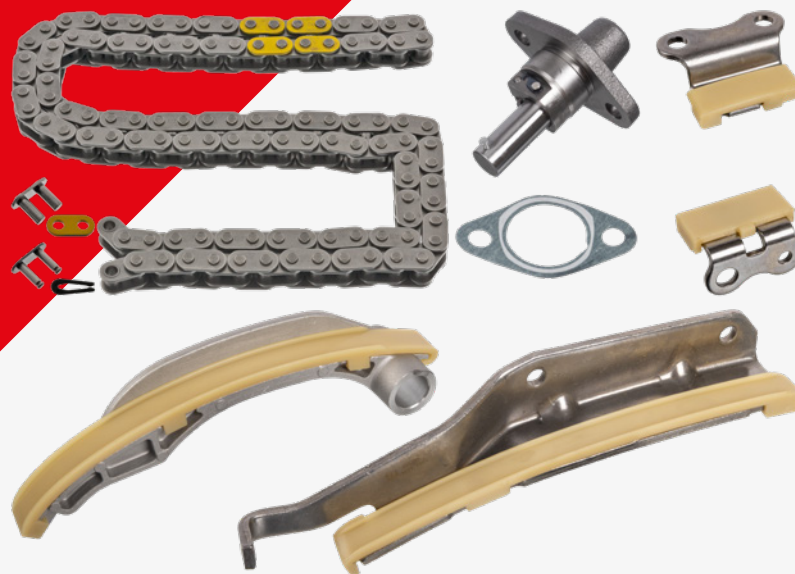
A rattling noise coming from the engine timing chain area or a broken timing chain.

The timing chain tensioner's wear is accelerated during operation. This is caused by the high carbon deposits that build up in the oil, due to exhaust emission control measures implemented on this engine.

It is possible the tensioner will stick and no longer function properly. This in turn will result in an un-tensioned timing chain, causing a rattling noise or the chain to break.

Remove the timing chain tensioner and inspect it for excess wear, damage and over extension of the plunger. This is checked by looking at the scratch marks between the contact surface of the cam and the plunger rack. If the plunger has extended beyond the normal operating range, there will be marks from the seventh position onwards. The cam can also sustain damage to the teeth, therefore restricting the operation of the cam.

Remove the rocker cover assembly. Using a flat blade screwdriver, raise the timing chain off the timing chain guide surface and inspect the condition of the chain running surface. A pitted wear surface is caused by a flapping untensioned timing chain.

Once the cause has been confirmed, replace the timing chain kit according the workshop manual, including changing the engine oil and filter.
