to fit:
Renault Clio 3

Wiper motor

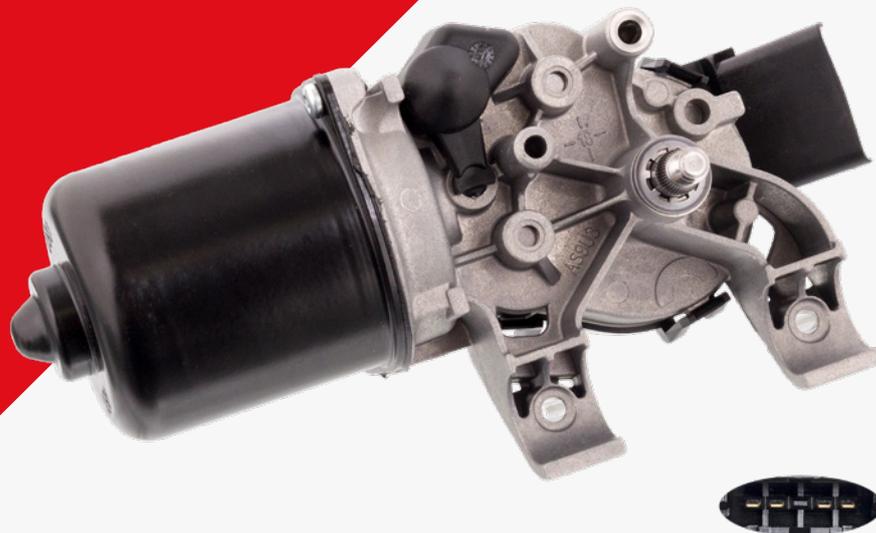
The wiper motor is submerged in rainwater and fails due to water ingress.

Over time, road debris and fallen leaves can block the water drain tubes in the scuttle panel below the front windscreen. This causes the area to fill with rainwater - submerging the wiper motor and linkage. This constant immersion in water gradually leads to the penetration of the casing and, ultimately, to motor failure.

Remove the faulty wiper motor and linkage. Clean out the drain tubes using a suitable piece of wire and flush through - with water - to make sure that the one-way valve (rubber flap) is clean and not sticking. Check the wiring loom connector is free from corrosion; clean or replace as necessary.

Before replacing the wiper motor, check that the wiper linkage is in good working condition and has not seized, or has any excess 'play' in the joints. If found to be seized or sufficiently 'worn', replace the linkage as well as the faulty wiper motor.
