To fit:
various Mercedes-Benz models

Cable for camshaft sensor

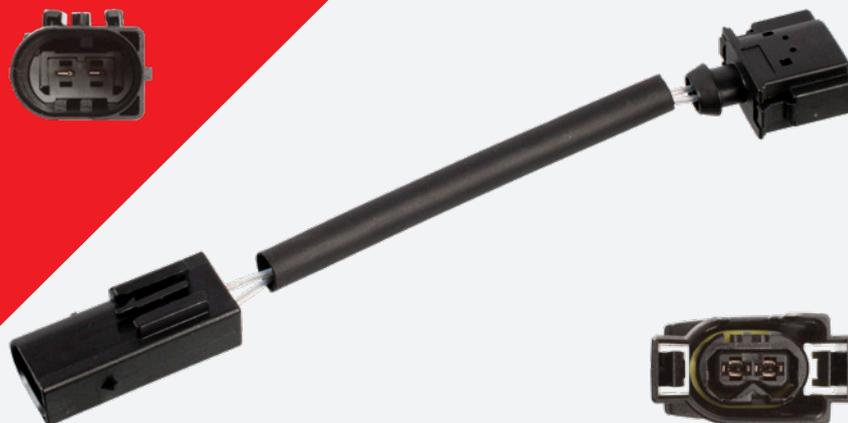
The engine management warning lamp is illuminated, with various fault code entries - referring to the oxygen sensors - logged in the engine control unit.

A malfunction of one - or both - of the oxygen sensors, due to the capillary action of the engine oil reaching the engine wiring harness. In turn, this affects the sensors via the camshaft-control solenoid valve.

Check all oxygen sensors for oil ingress and replace if necessary.

Check all camshaft-control solenoid valves for oil leaks and replace if necessary.

Locate any other contamination caused by loss of engine oil, and carry out any necessary repairs.

Install adaptor cable set 107574 between the camshaft-control solenoid valve and the engine wiring harness. The fine copper sleeves incorporated into this adaptor cable prevent the oil from spreading, reducing the risk of future electronic failures. It is recommended to install one adaptor cable for each camshaft-control solenoid valve fitted to the vehicle.

Check the engine oil level according to the manufacturer's specifications and correct if necessary.
