febi 107124, 107125

To fit:
BMW 3-Series E91 Touring

Wiring Harness Repair Kit for tailgate

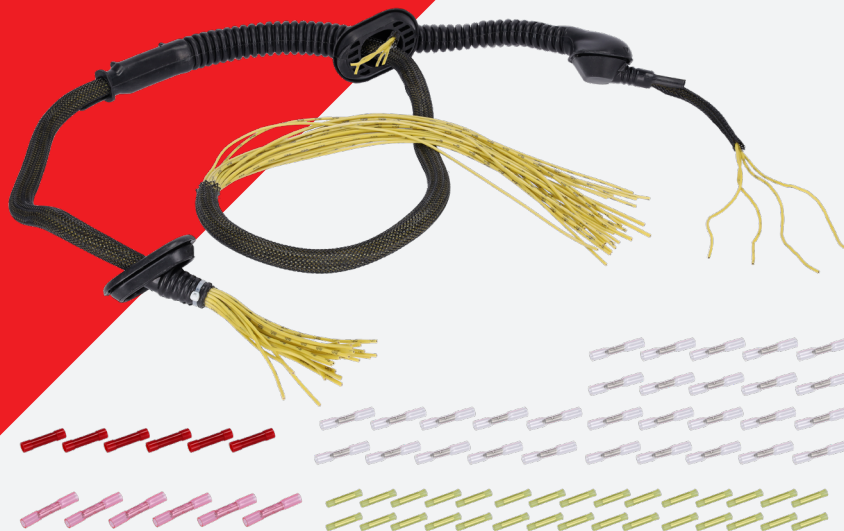
The central locking systems fail to unlock when using the remote key fob. However, the central locking unlocks normally when using the vehicle's key in the driver's door lock.

This is a common fault on the 'Touring' model and is usually due to the wiring harness between the body and tailgate becoming 'brittle' with age. This, combined with the frequent opening and closing of the tailgate, contributes to stressing and straining the wiring. Eventually, the insulation cracks - leaving the wiring exposed, which results in short or open circuits.

Disconnect the vehicle's battery; each wire of the original harness should cut to size. Strip the insulation, then the joining connector, and 'crimp' into position whilst attaching the original harness to the new wire.

Once complete, refit the rubber gaiter and grommets into the vehicle's body and tailgate. Reconnect the battery. Check for flexibility of the new wiring harness when opening and closing the tailgate. Clear any fault codes and test the operation of all affected electrical systems.
