Various Volkswagen, Audi, Seat and Skoda models fitted with the 1.4 litre TDi engine.

Water Pump with sealing ring

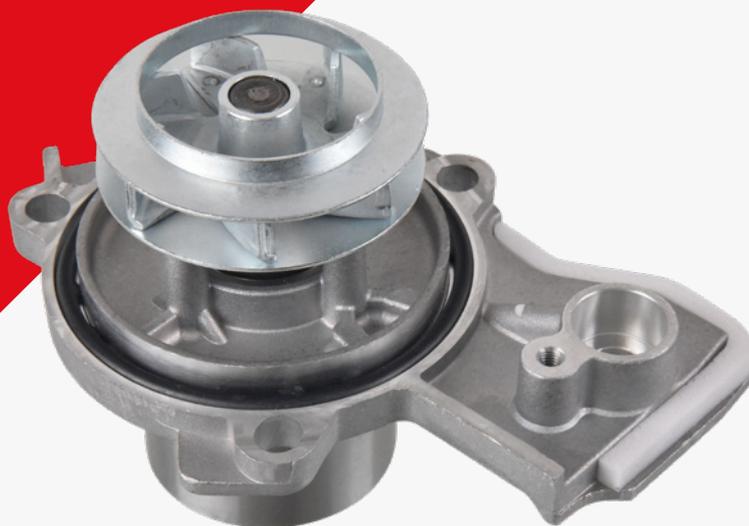
Engine overheating, coolant temperature gauge reading over 110° C and poor interior heater performance. Also cooling system fault codes maybe logged in the engine control unit.

The water pump fitted to these vehicles has an ECU controlled collar, which interrupts the coolant flow to make the engine more thermally efficient. However, the control collar can become seized, or the plastic impeller can break up or come away from the shaft.

Ensure the engine is cool, then remove the coolant filler cap. Remove the small pipe to the coolant header tank and hold this over the filler neck of the header tank, there should be a small trickle of coolant flowing with the engine at idle. This should increase in flow when the engine speed is increased. If the flow rate does not increase, this would suggest a faulty water pump.

Replace the defective water pump with febi 108778, this is a conventional water pump, which eliminates the potential failure caused by the control collar. The solenoid valve must be removed from the old pump and fitted to the new pump. This is so the engine management system can recognise it. Failure to replace the solenoid valve will log an engine management fault.

Fill the cooling system with the correct coolant, then vacuum bleed the cooling system. Finally carry out the cooling system bleeding procedure, using a suitable serial diagnostic tool, to expel all the air from the cooling system.
