febi 12002

- VW Sharan (ref. no. 7M3 411 371C)
- Seat Alhambra (ref. no. 7M3 411 317C)
- Ford Galaxy (ref. no. 1 361 653)

Connecting Rod

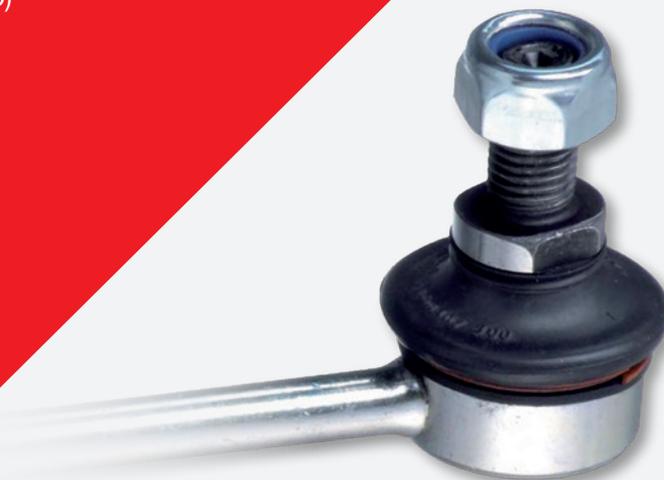
Problem

The parts cause noise whilst driving.

Due to its design and location (refer to picture 1) the connecting rod is subject to strong external forces. Both joints are completely exposed to water spraying up from wet roads. A damaged rubber boot (refer to picture 2 and 3), i.e. damaged by road debris, makes it easier for water and dirt to find its way into the joints. Consequently the protective grease will be washed out and the ball pin oxidises. As a result of this, the roughened ball surface increases wear to the plastic ball cup (refer to picture 4), which leads to the joint moving around and causing noise.

Rubber bellows (refer to picture 5):

- High performance rubber compound ensures the required flexibility
- Shaped to seal the joint system at each angle
- Proven grease resistance

Piston rings (refer to picture 6):

- The locking rings are specifically designed for this application, in order to support the sealing characteristics of the rubber boot

The grease:

- Use of high performance grease for the ideal lubrication of the ball cup (refer to picture 7) and the ball pin
- Corrosion protection for the whole system
