febi 176483, 176525

To fit:
various Audi and Volkswagen models
with the V6 TDi engine

Intake manifold with swirl flap actuator and gasket

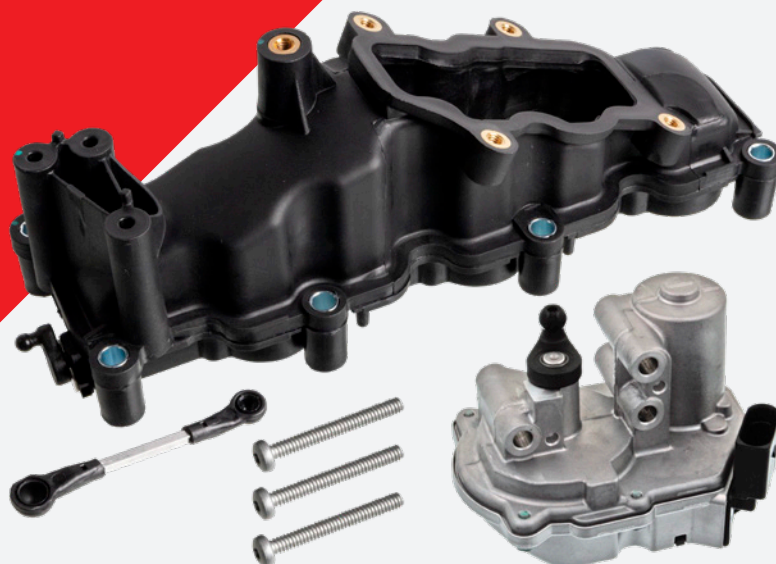
The engine performance and drivability is poor, and the engine warning lamp is illuminated.

Excess carbon build-up in the inlet manifold prevents the swirl flaps from opening or closing completely. This puts unnecessary strain on the linkage and actuator, leading to a broken or worn linkage. As a result, the actuator operates out of its designed tolerances and the following fault code is logged in the engine control unit: P2015 - intake manifold flap position/signal improbable.

For this repair, febi provides a combined kit containing the inlet manifold, gasket and swirl flap adjustment motor and linkage for each manifold. Following the successful completion of the replacement, the swirl flap system has a 'learning' procedure take place - for this, a suitable diagnostic tool is required.
