BMW X3 (E83), X5 (E53, E70), X6 (E71, E72)

## Adjustment motor for transfer case

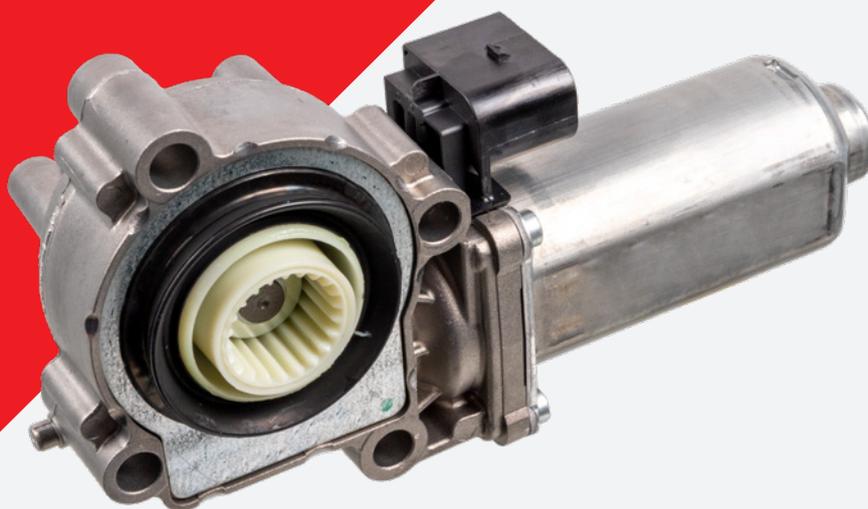
A clicking noise can be heard from underneath the vehicle - around the area of the transfer case - when switching the ignition on or off.

The engine is jerky in operation when accelerating in lower gears.

The ABS, 4x4 and brake system warning lamps are illuminated - related to the symptoms listed above. These possible fault codes may be stored in the transfer case control unit:

- 539E Control motor or transfer case faulty.
- 5463 Transfer case mechanical fault.

Wear of the transfer case adjustment motor drive gear - often caused by an excessive variance of tyre tread depths between the front and the rear axle.

To check that all systems are fully functional, carry out a full system scan of all fault codes using a suitable diagnostic tool.

Check the transfer case adjustment motor operation and replace as necessary, then clear/reset all fault codes after the repair.

Check the tread depths of all the tyres and replace as necessary.
