Range Rover (L405), Range Rover Sport (L320, L494)

Additional water pump

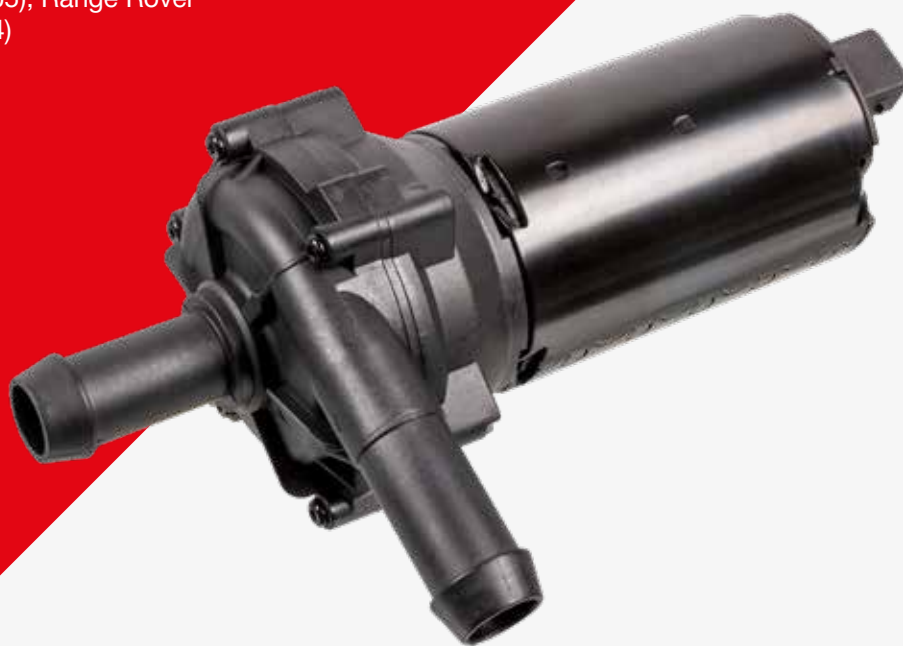
Reduced engine performance and/or cylinder misfire when under load and at high road speed. The engine warning lamp is illuminated, related to the symptoms listed above.

On Range Rover (LM) Supercharged 6A198058 to 7A261419 and Range Rover Sport (LS) Supercharged 6A901924 to 7A109767 vehicles, the electrical harness positive supply and the negative within the connector C3006, for the auxiliary water pump, may have been manufactured incorrectly. The two wires within the electrical connector for the water pump were wired incorrectly, causing the pump to run in the opposite direction. The ECU will reduce engine performance to prevent damage to the engine because of the decreased coolant flow.

Using a voltmeter, check the positive and negative wiring orientation within connector C3006. If found to be wired incorrectly, use a terminal extractor tool and swap cavity 1 and cavity 2 wires to the correct positions.

Afterwards, replace the auxiliary water pump and top-up the cooling system with the correct coolant. Clear any fault codes relating to the symptoms with a suitable diagnostic tool.
