febi 186633

Mazda CX3 2015>, CX5 I 2011 > 2016, CX5 II 2016>, Mazda2 III 2014 > 2022, Mazda3 III 2013 > 2019, Mazda6 III 2012>, MX30 2020>

Engines 1.5i, 2.0i, 2.5i

Ignition Coil

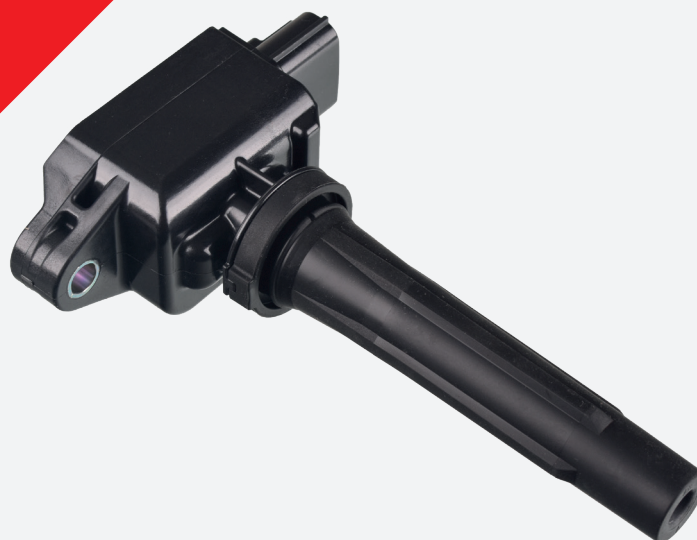
Vehicle symptoms include a lack of engine power and an inconsistent idle, combined with the engine malfunction indicator lamp being illuminated on the instrument cluster. Engine Control Unit (ECU) diagnostics will reveal the following possible fault codes:

Over time the insulation found between the primary and secondary coil windings is degraded by heat and vibration. This deterioration causes fractures to form in the secondary coil windings, leading it to overheat and fail, resulting in a misfire.

Note: There is a known issue which affected some pre-2017 vehicles fitted with ignition coils manufactured by Yumebishi.

First, use suitable diagnostic equipment to identify which ignition coil is causing the misfire. Alternatively, this can be diagnosed manually by removing each spark plug and systematically testing the coils to establish which is not firing correctly.

Each ignition coil is required to provide a high voltage to bridge the electrode gap. If the ignition coil insulation is degraded, additional load will be placed upon the system. Therefore, when the faulty ignition coil has been identified, it is wise to check the condition of the plugs themselves as they too can deteriorate with age, further increasing the load on the system.

Disconnect the battery and replace the failed ignition coil (or coils) with febi Ignition Coil 186633 and spark plugs as necessary. Finally, reconnect the battery and clear any fault codes using a suitable diagnostic tool.
