febi 186290

Various Volkswagen, Audi, SEAT,
Škoda and MAN models.
1.6 & 2.0 TDI engines

Water Pump

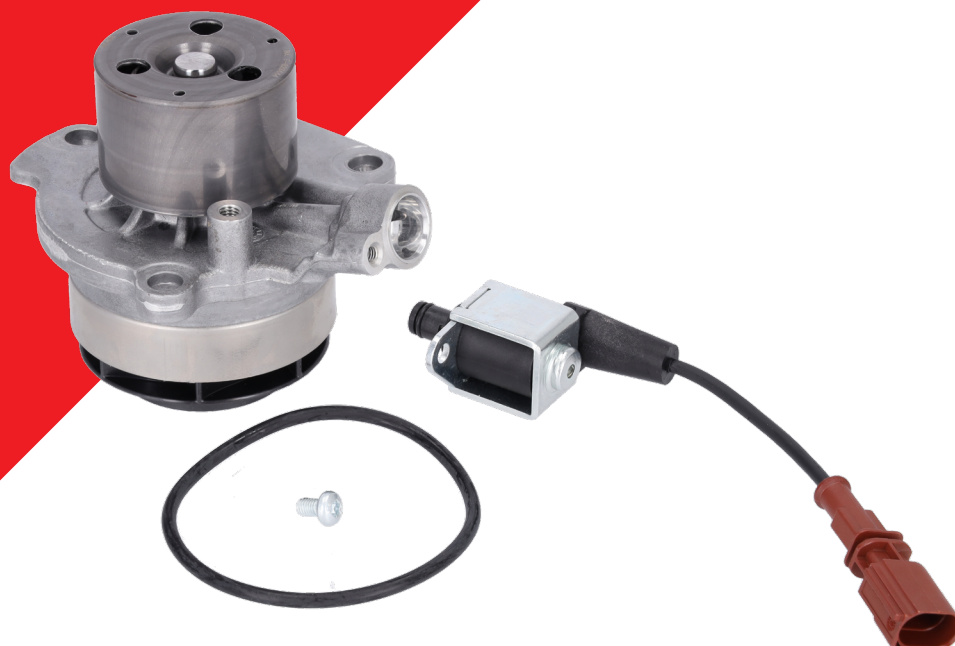
Engine overheating, coolant temperature gauge reading over 110° C, poor interior heater performance. Cooling system fault codes may also be logged in the engine control unit.

The water pump fitted to these vehicles has an ECU-controlled collar which interrupts the coolant flow to make the engine more thermally efficient. However, the control collar can become seized, the plastic impeller can break up, or the impeller can come away from the shaft.

Ensure the engine is cool, then remove the coolant filler cap. Remove the small pipe to the coolant header tank and hold this over the filler neck of the header tank; there should be a small trickle of coolant flowing with the engine at idle. This should increase in flow when the engine speed rises. If it does not, this would suggest a faulty water pump.

Replace the defective water pump with febi replacement part 186290. This part has an improved control collar design which has been significantly tested to eliminate the potential failure of the original water pump.

Assemble the water pump with the new solenoid valve and seals, both provided in the kit.

Fill the cooling system with the correct coolant, then vacuum bleed the cooling system. Finally, using a suitable serial diagnostic tool, carry out the cooling system bleeding procedure to expel all the air from the cooling system.
