To fit:
Various Mercedes-Benz models

Rubber Metal Bush for Wheel Bearing Housing

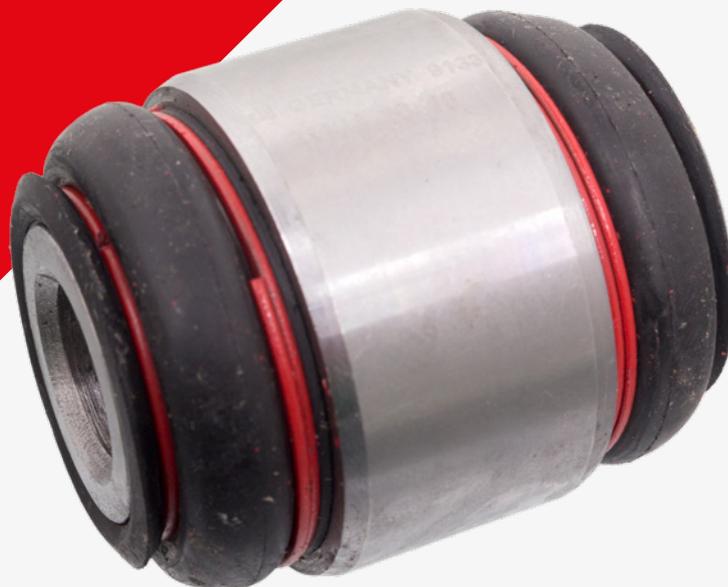
Knocking or creaking noises may be heard from the rear axle area while driving.

The original design of this bush is very susceptible to wear. This stems from insufficient internal lubrication. Wear is accelerated when the vehicle is driven in harsh road and weather conditions.

febi 21174 has been improved. The modified bush has several channels instead of just one. This ensures a permanent supply of lubricant which lengthens the bush's service life.
