# febi 24414

Audi A2, Seat Cordoba, Ibiza IV,  
Škoda Fabia, VW Polo, Fox

Repl. No. 6C0 407 621

## Wheel bearing kit including wheel bearing and axle nut

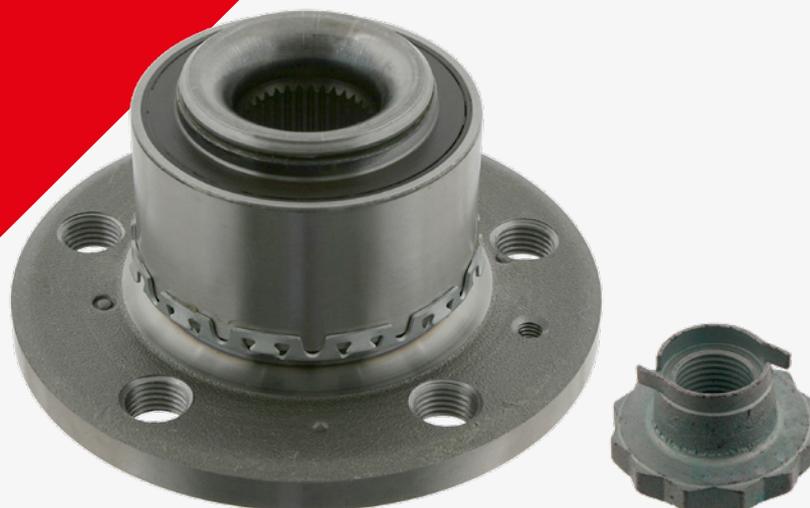
The wheel bearing makes a lot of noise when driving.

Water is getting into the wheel bearing due to a damaged sealing washer and rust is forming, see photos (1) and (2). The sealing washer (3) located between the CV joint and the wheel hub is made of plastic and is easily damaged during removal or due to external factors. When the sealing washer is damaged, it no longer makes proper contact. Water can get inside the wheel bearing more easily once the sealing washer is damaged or dirty. The consequences are premature failure of the bearing and a lot of noise.

Look out for damage to the sealing washer! As a general rule, febi recommends replacing the sealing washer when fitting a wheel bearing. Important: The sealing washer comes in two sizes (64 mm and 72 mm). Pay particular attention to the size (in inches) of the wheels!

Using inappropriate tools for fitting may cause premature failure of the wheel bearing and may also cause a fault indication in the ABS system. Please follow the vehicle manufacturer's repair instructions!
